TRENCHLESS ASIA 2026

PIPELINE HIGH ACCURACY DETECTION TECHNOLOGY - PANORAMIC QUANTITATIVE ROBOT

ELLA XIAO

WUHAN EASY-SIGHT

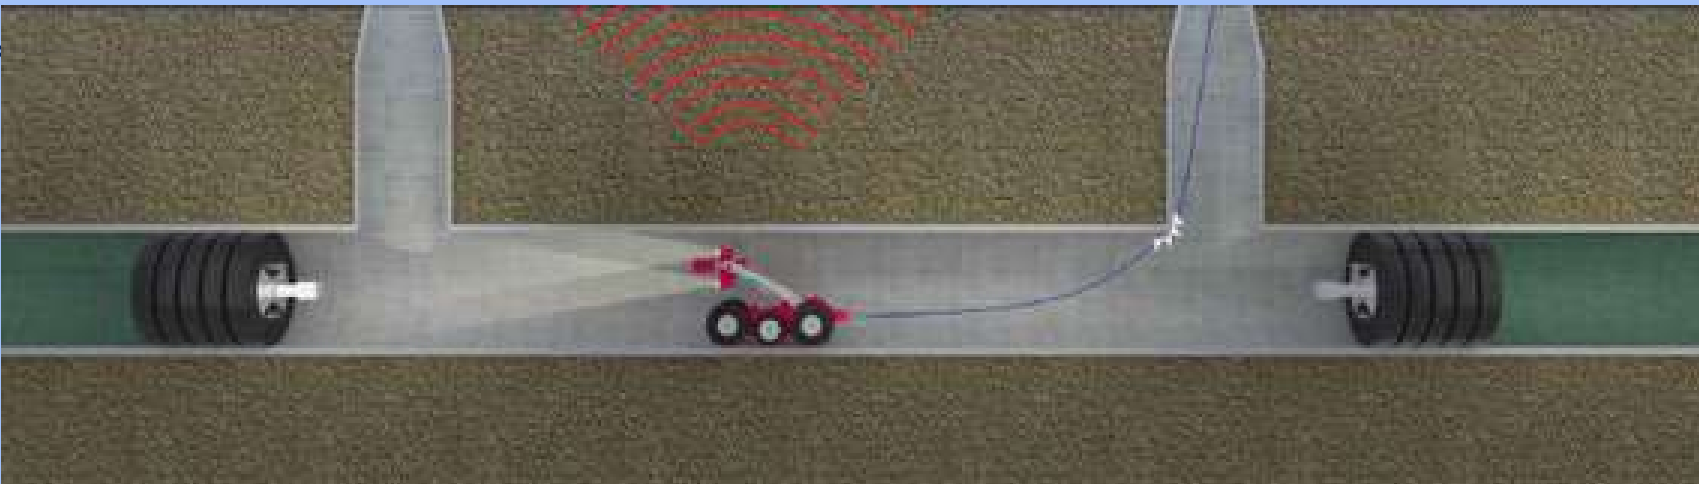
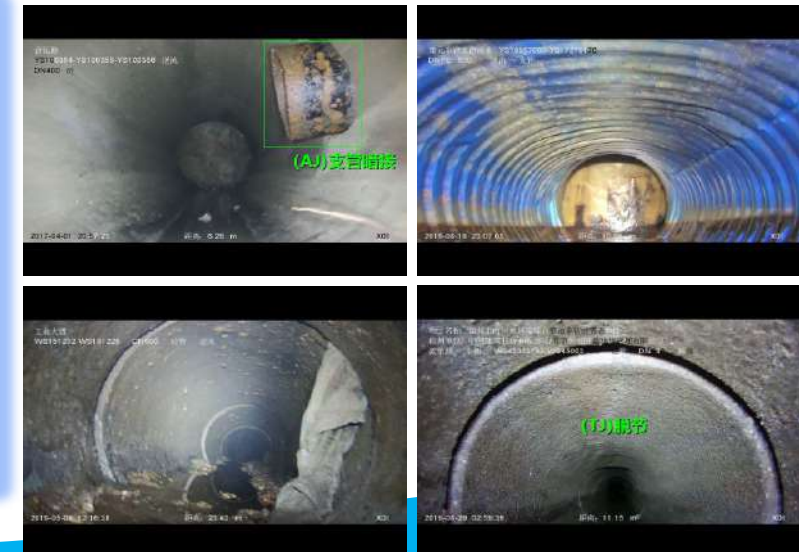
The main disadvantages of current CCTV inspection

The most common inspection tool at present is the CCTV inspection system, which has the following main disadvantages:

- **Complex operation process:** During the inspection process, the camera head cannot be adjusted to find defects; when defects are found, it is necessary to stop and observe the defects carefully.
- **Low interpretation efficiency:** The staff in the office repeatedly watch the inspection video to interpret the defects. If the defects are missed when recording the video, it will be impossible to interpret.
- **Defect interpretation based on experience:** The size, length, area, etc. of the defect cannot be accurately quantified, and the pipeline assessment score obtained is inaccurate.

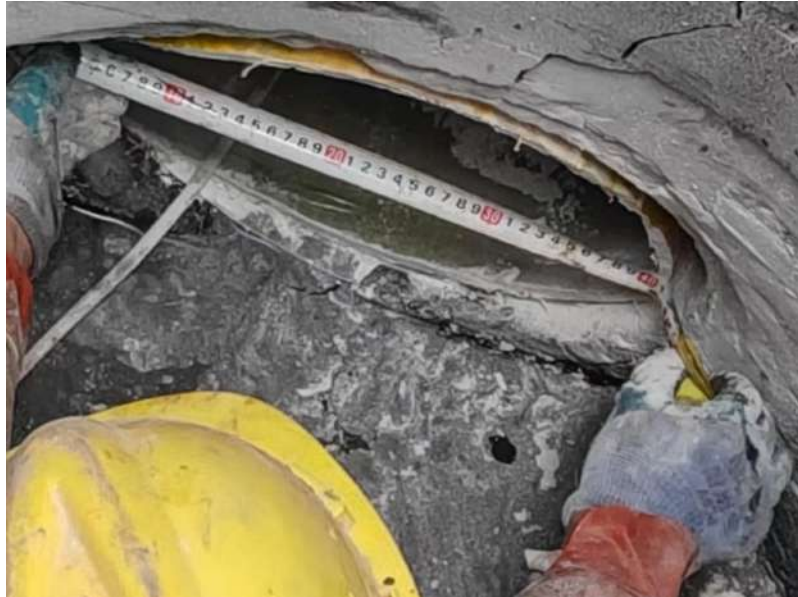
The liner size is too small: **the liner does not fit the pipe to be repaired**

At a project site, the ordered liner size is DN415, and the actual pipe diameter is DN440. After the curing is completed, the liner does not fit the pipe to be repaired at all.

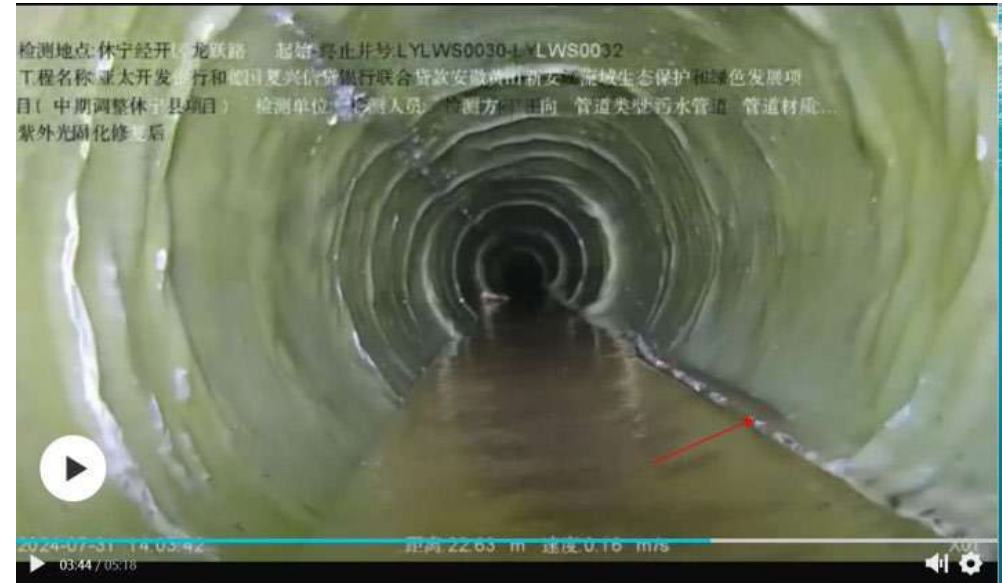
The liner size is too large: **the liner expands and forms radial extrusion**

At a project site, the ordered liner size is DN300, and the actual pipe diameter is DN270. After curing, there are a lot of circumferential wrinkles inside the pipeline liner.

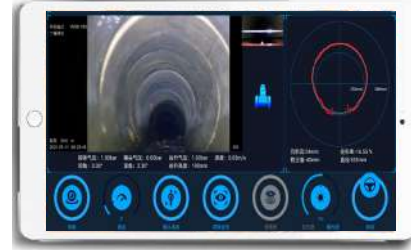
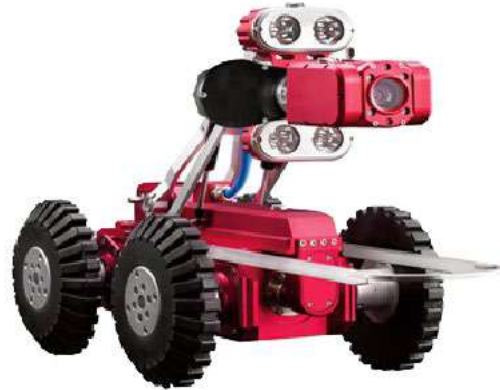
2016

The first one to realize digital high-definition pipeline inspection

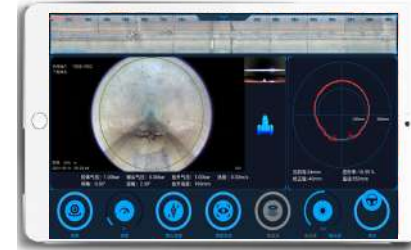
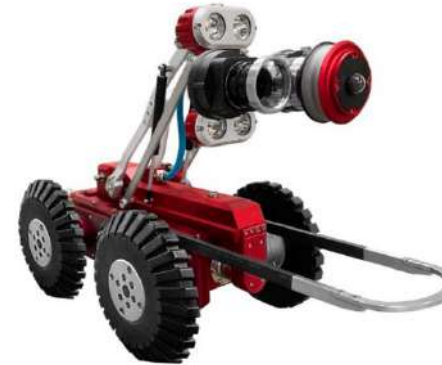
2020

Launched laser quantitative detection technology with centimeter-level accuracy

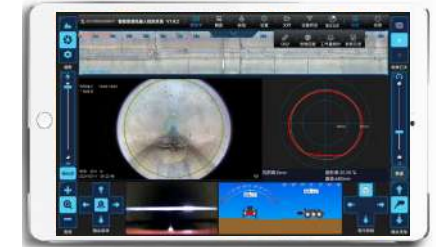
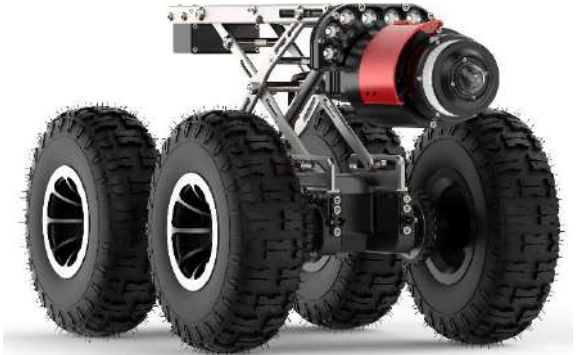
2021

Upgraded to panoramic lidar quantitative detection, comprehensive collection of high-definition video, chromatogram, lidar profile map, and comprehensive analysis

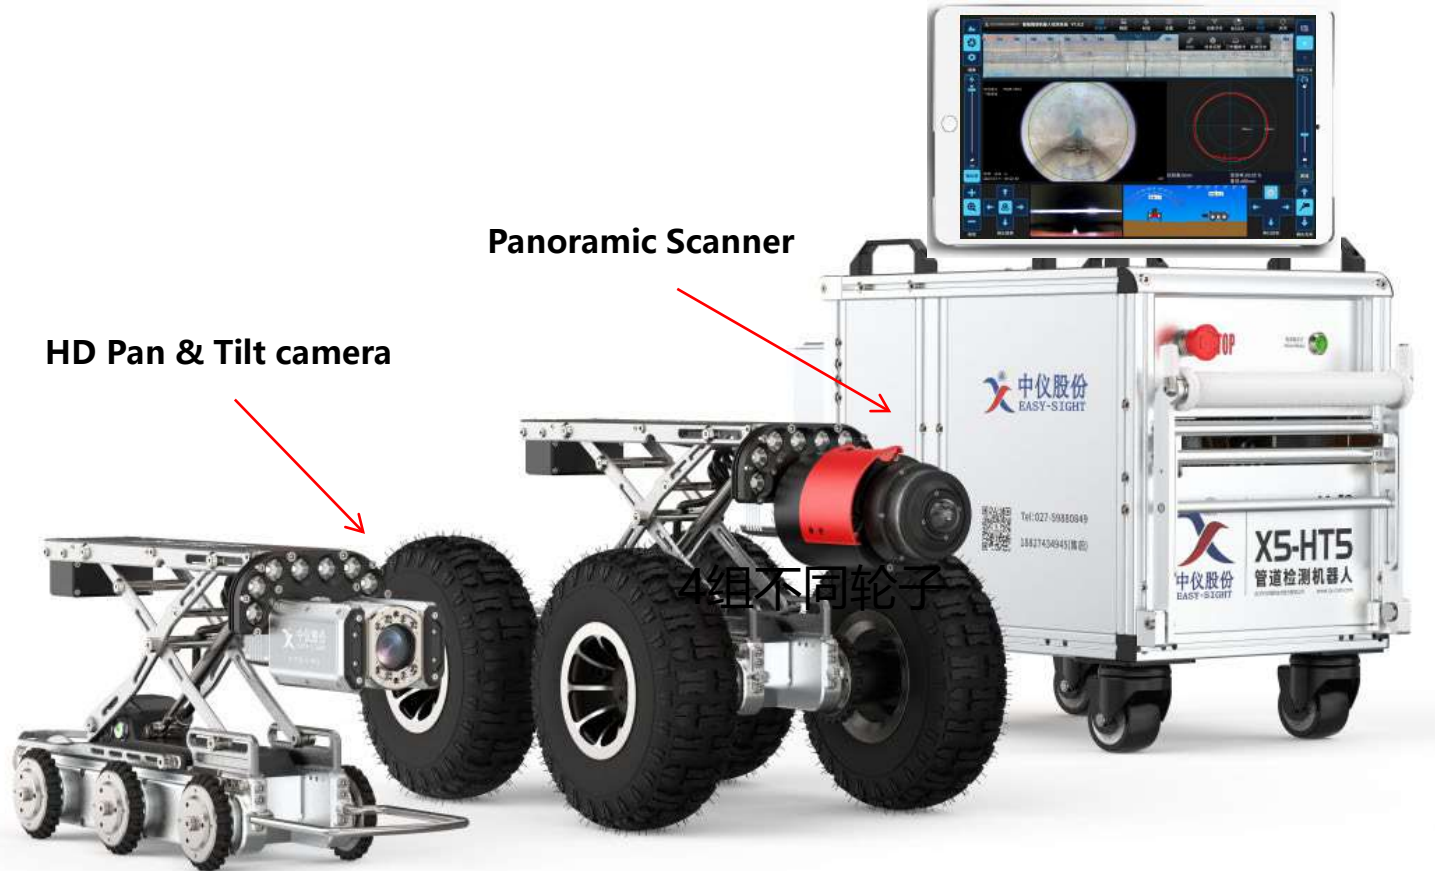
X5-HT5 Pipeline Inspection Robot

It can perform millimeter-level high-precision measurements of pipeline parameters such as pipe diameter, deformation, deposition, and defect size, providing accurate data support for maintenance and repair operations. It is suitable for engineering measurement tasks that require extremely high accuracy and reliability.

Millimeter-level measurement accuracy

500m long distance detection

190mm height gap X-type electric lift

Driving speed increased by 1.5 times

Quantitative detection speed increased by 2 times

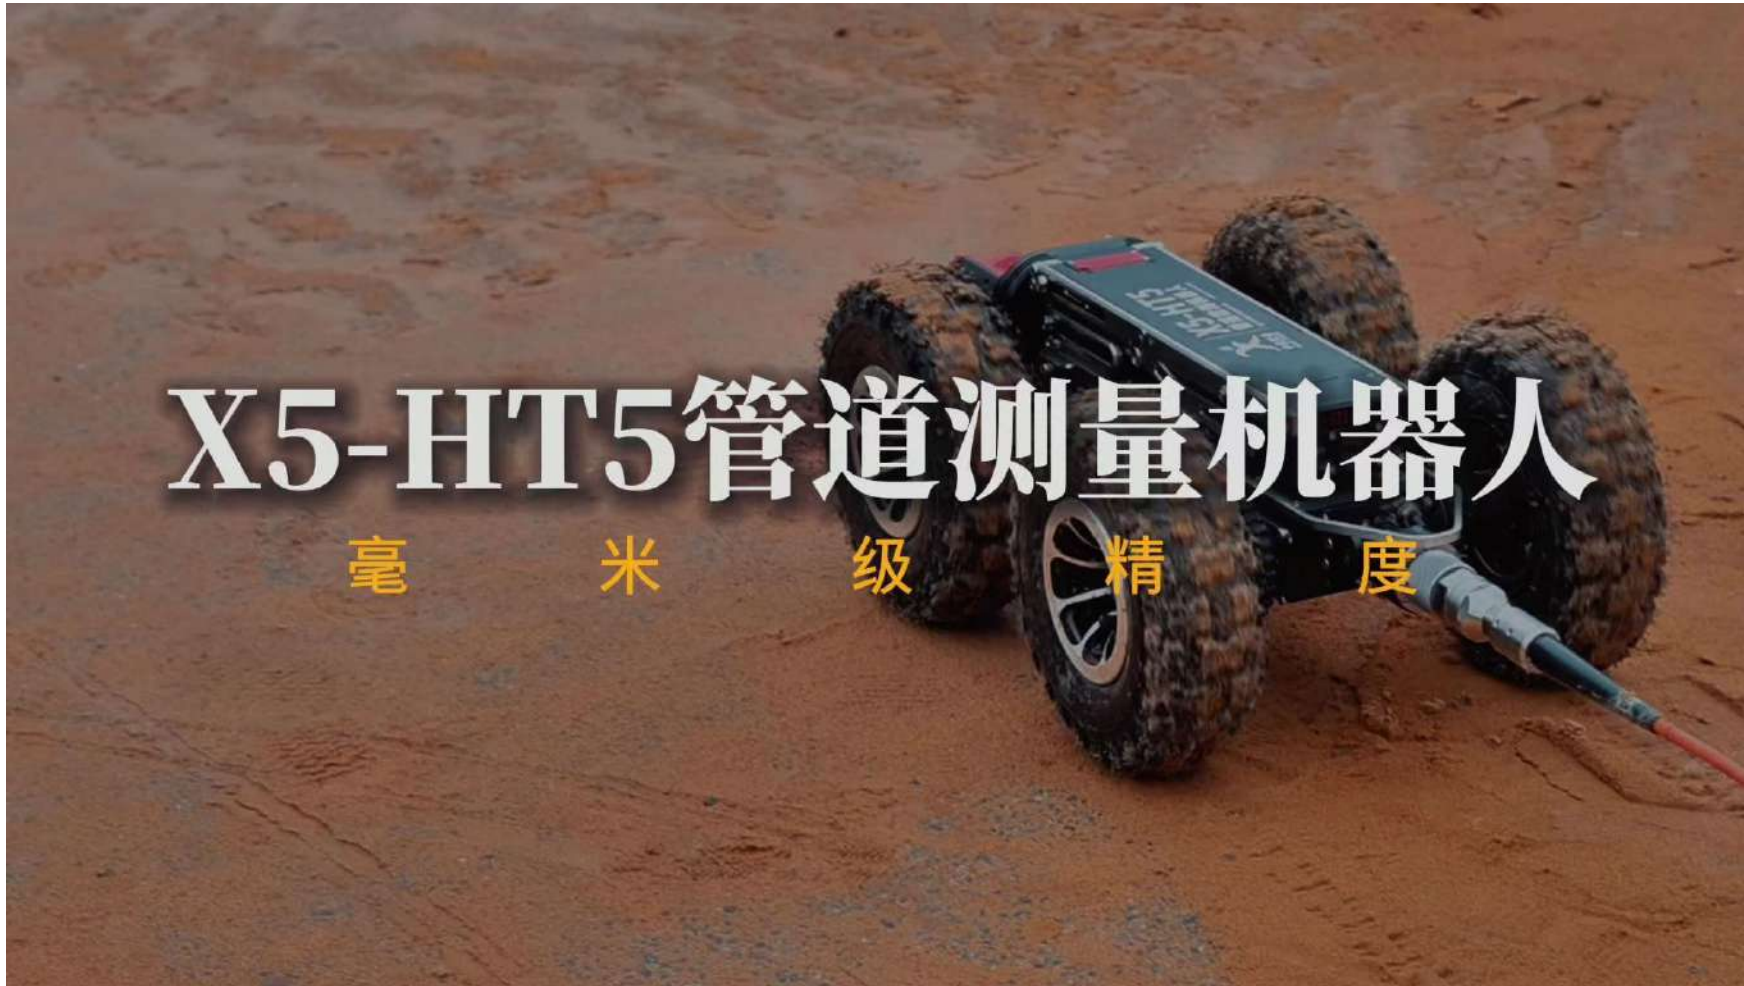
X5-HT5 Pipeline Inspection Robot

Inspection Robot

Panoramic display: present the whole view of the pipeline in one picture
Lidar quantification: Defects can be accurately quantified

When inspecting, just set the inspection parameters, and the crawler will crawl automatically without stopping, observing defects, or rotating the lens; after the inspection is completed, data is generated and analyzed immediately; When interpreting, interpret and analyze on the pipeline panorama and chromatogram; when clicking on a defect, it will automatically associate with the corresponding video frame and lidar contour data for precise quantification.

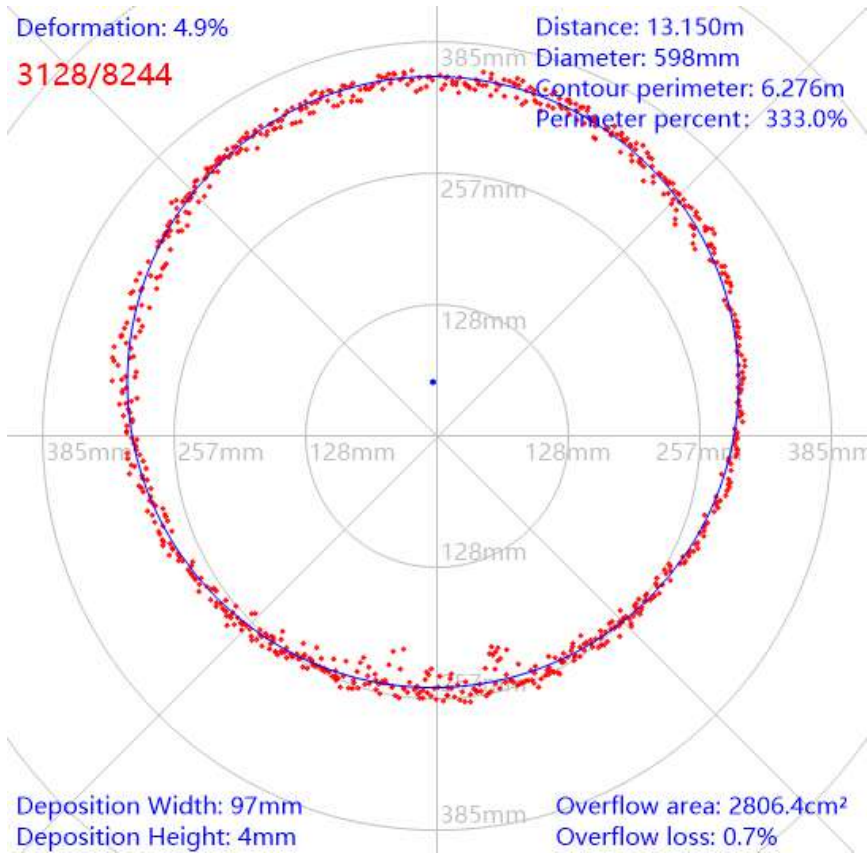
Regular lidar (centimeter grade)

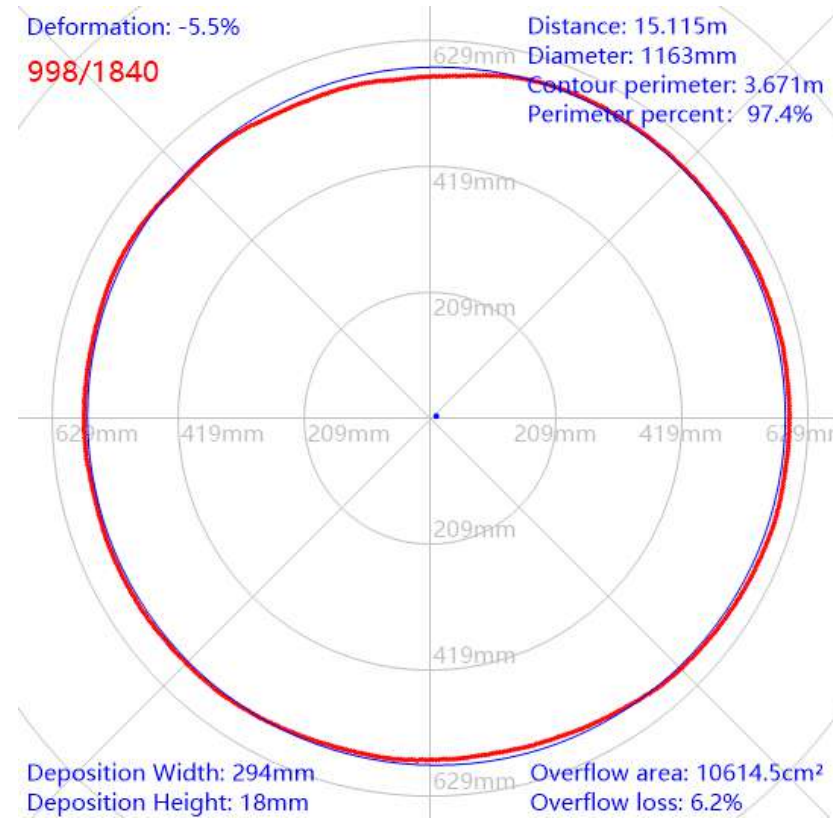
High accuracy lidar (millimeter grade)

The high accuracy lidar collects 800 points per frame, eliminating stray points and making the contours smoother.

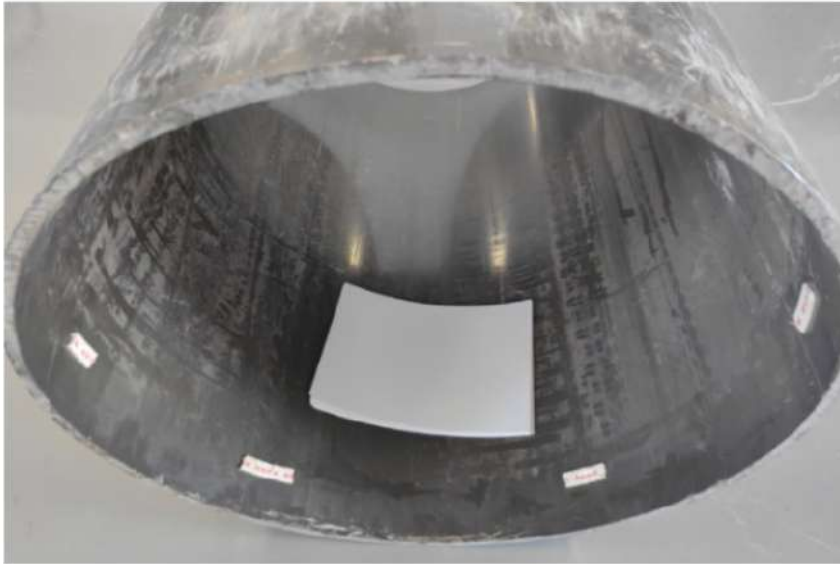
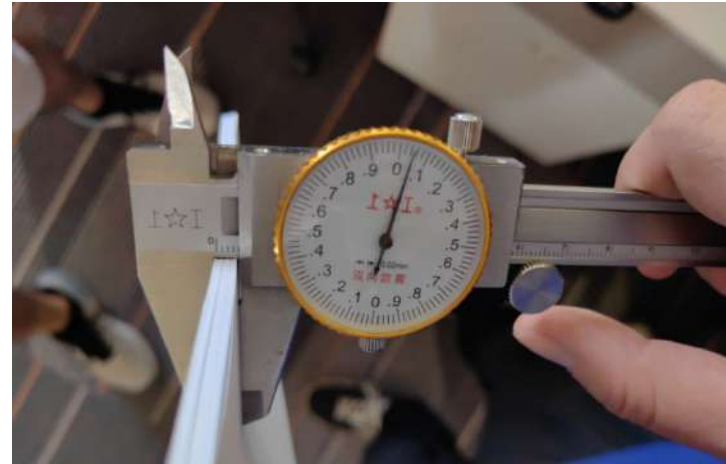
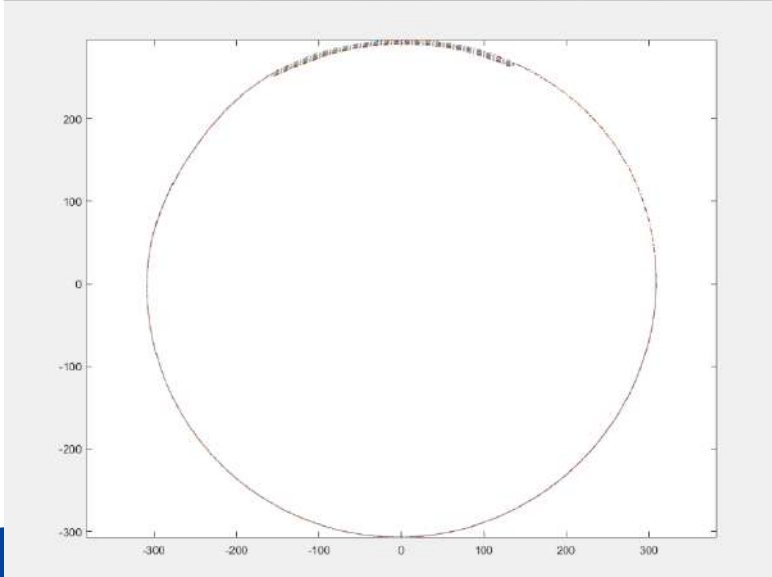
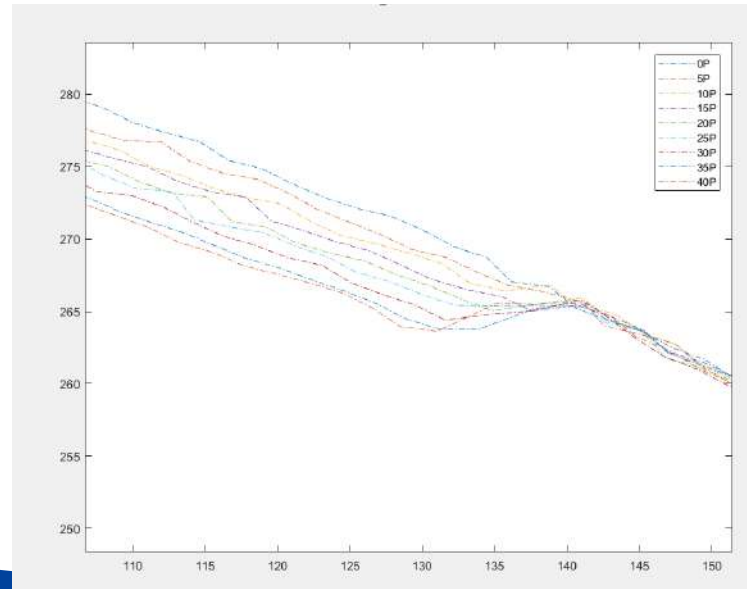
Verification and comparison

Place the lidar inside the pipe for scanning. Place 5, 10, 15, 20, 25, 30, 35, and 40 A4 papers at the bottom. Measured by caliper, the thickness of 40 papers is 4mm, so the resolution of every 5 papers is 0.5mm.

Through data statistics, it was found that there were clear dividing lines between different paper layers, and the display resolution was higher than 0.5mm.

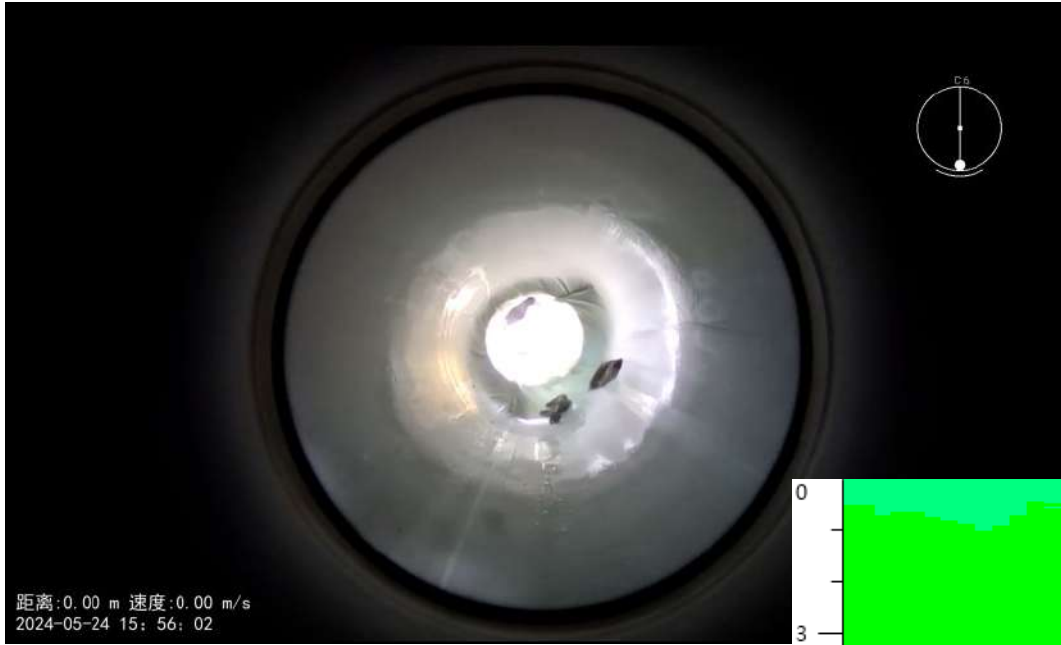
Hong Kong Verification:
Light-cured repair material for
DN600 pipe diameter

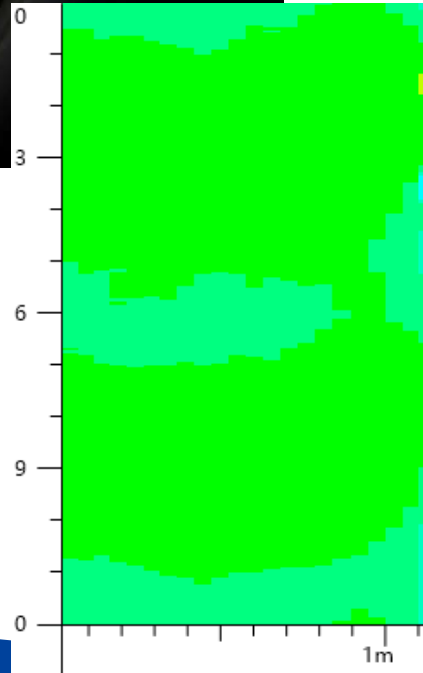
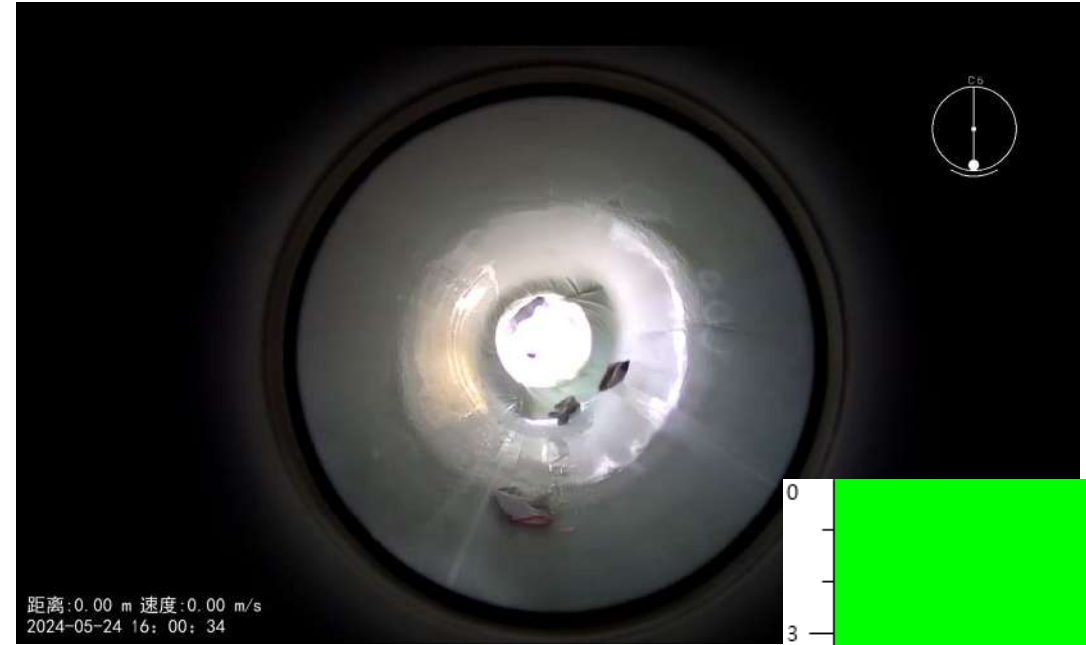
Chromatogram when three
people are stepping on it

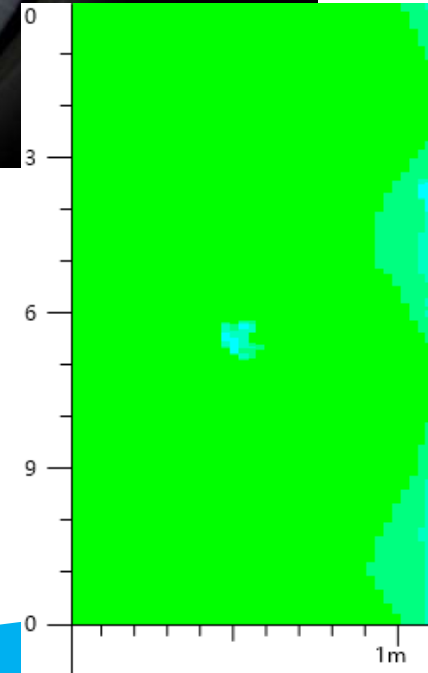
Chromatogram when no one is
stepping on it and one glove is
placed

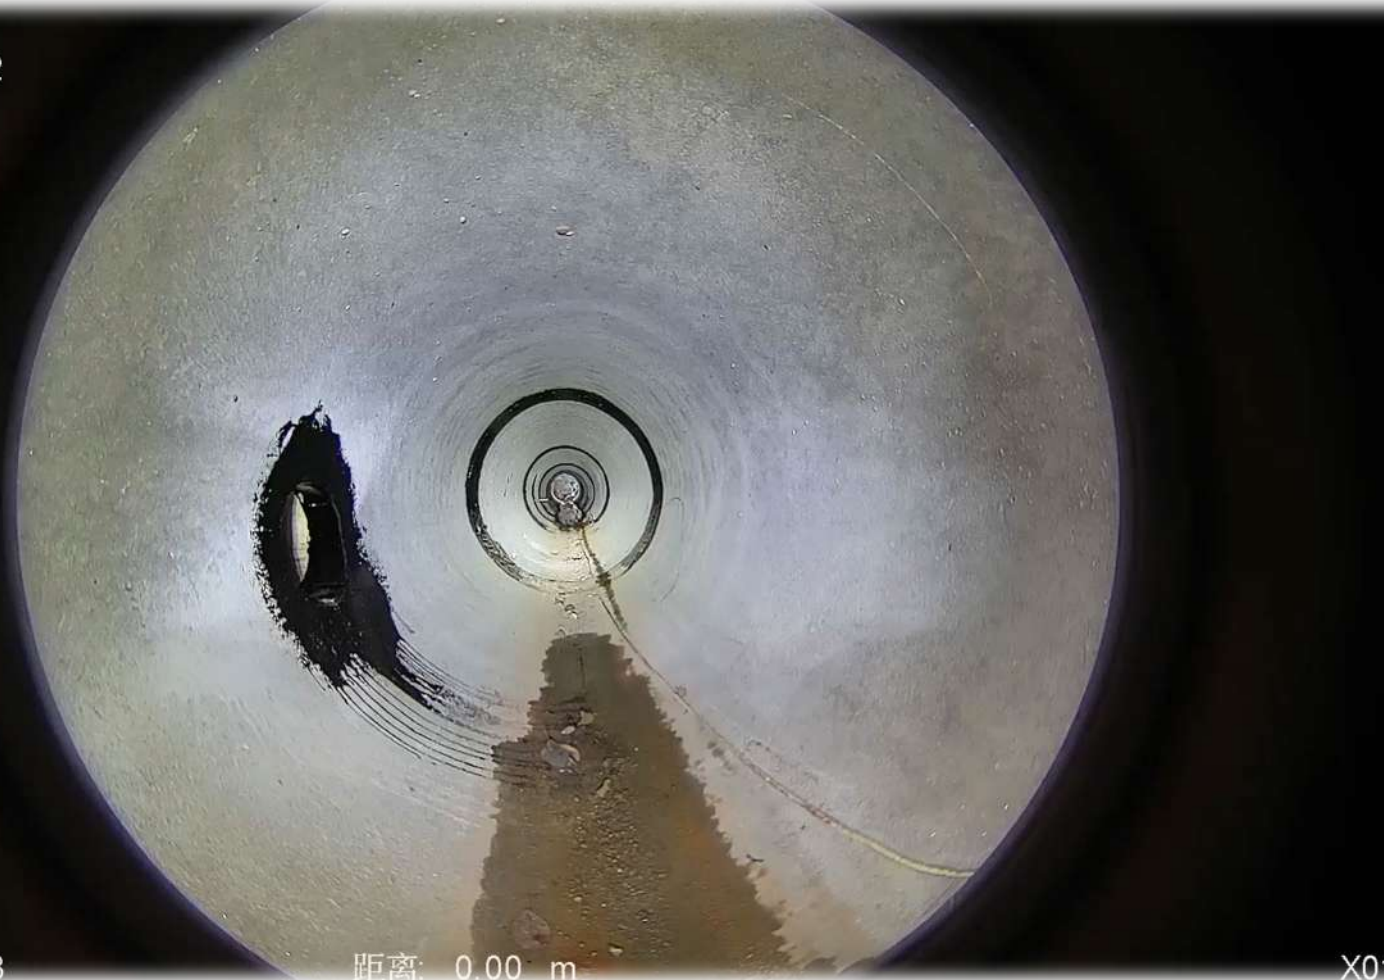
新厂房5 YS01-YS02
工程描述

The above picture is a panoramic view of the inside of the pipeline obtained using panoramic quantitative detection technology, which is equivalent to cutting the pipeline open and then laying it flat. From the above picture, you can clearly see the deposits on the bottom of the pipe, cracks on the pipe wall, etc.

- Lidar profile, chromatogram, panorama, video linkage analysis
- Automatic calculation of defect size
- Intuitive and simple interpretation

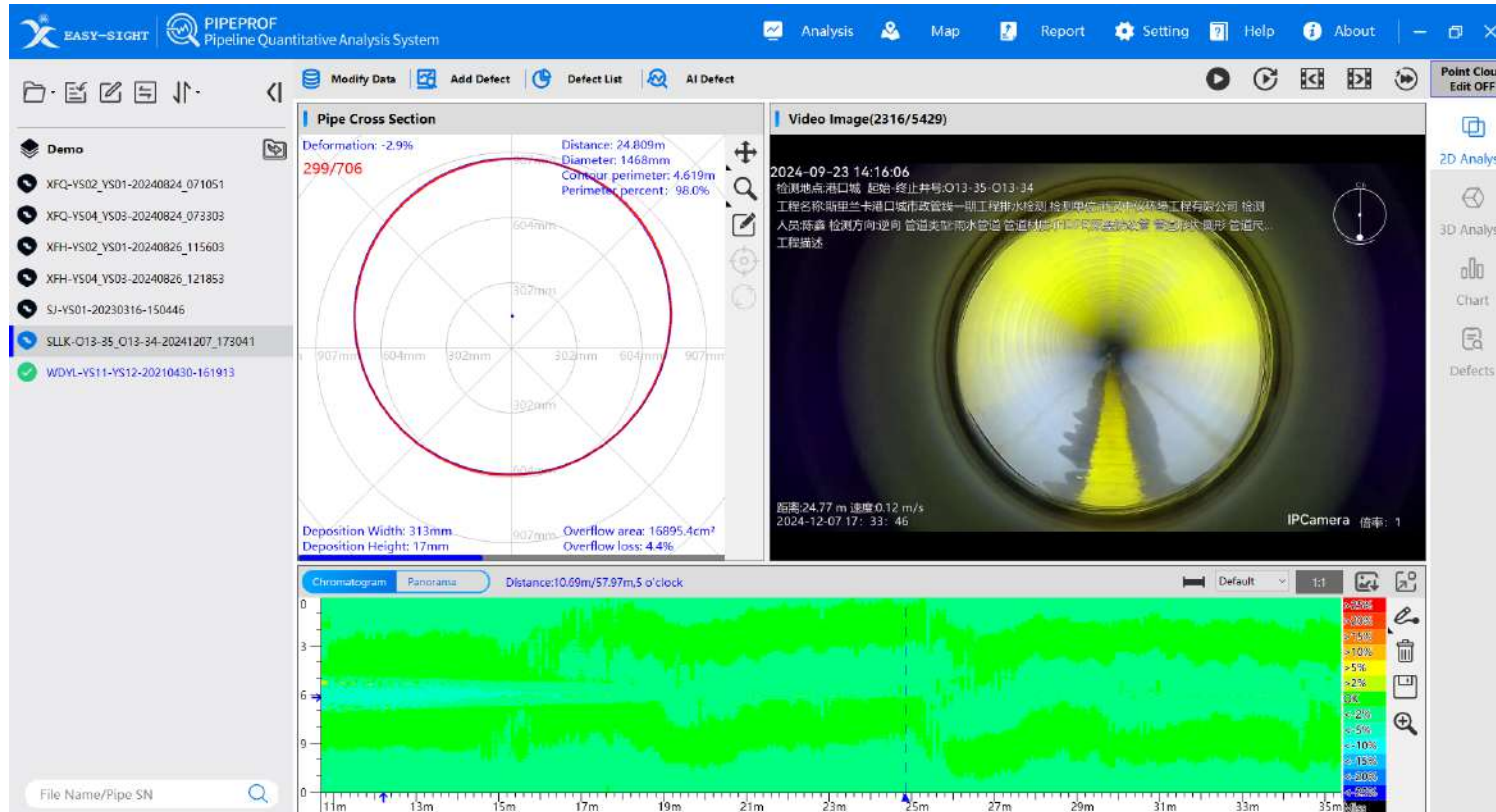
Intelligent defect analysis

Through the conditions set by the user, the defects are automatically judged according to the chromatogram expansion diagram, panoramic diagram, etc., and the automatic identification of various defects is supported.

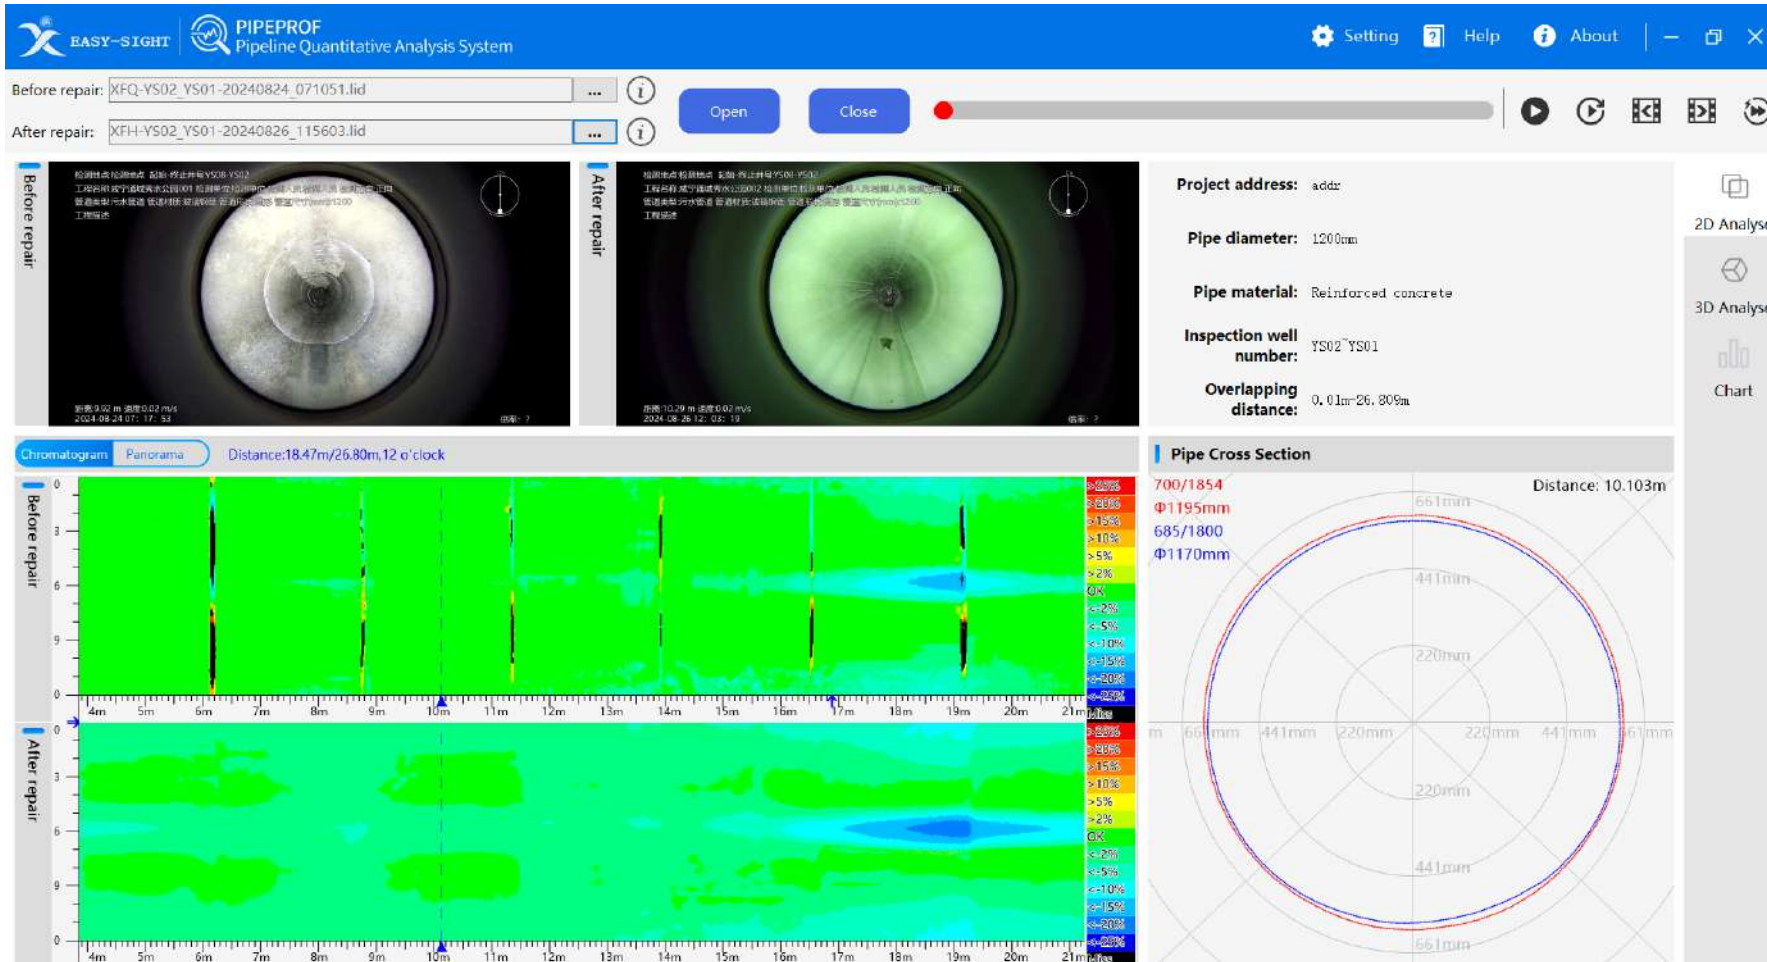
Comparative analysis before and after repair

➤ **2D analysis**

It can quickly view the video images before and after the pipeline repair, **the pipeline chromatogram expansion diagram, the pipeline panoramic expansion diagram, and the comparison diagram of the lidar cross-section profile.** It can accurately measure the thickness of the repair material.

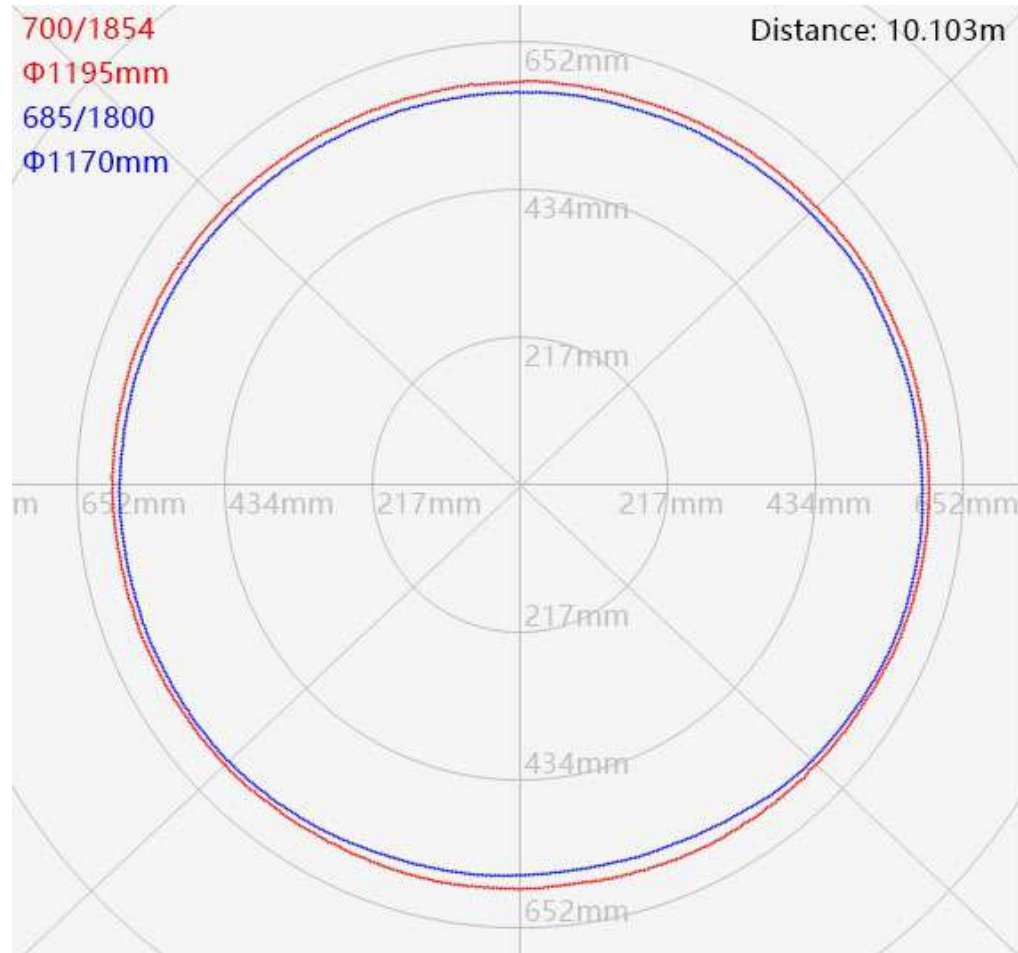
➤ 2D analysis - single frame profile comparison

The red part is the point cloud of the pipeline contour before repair, and the blue part is the point cloud of the pipeline contour after repair.

The distance difference at any clock position can be measured to calculate the wall thickness.

Each frame contour (one frame corresponds to one distance point) can be analyzed.

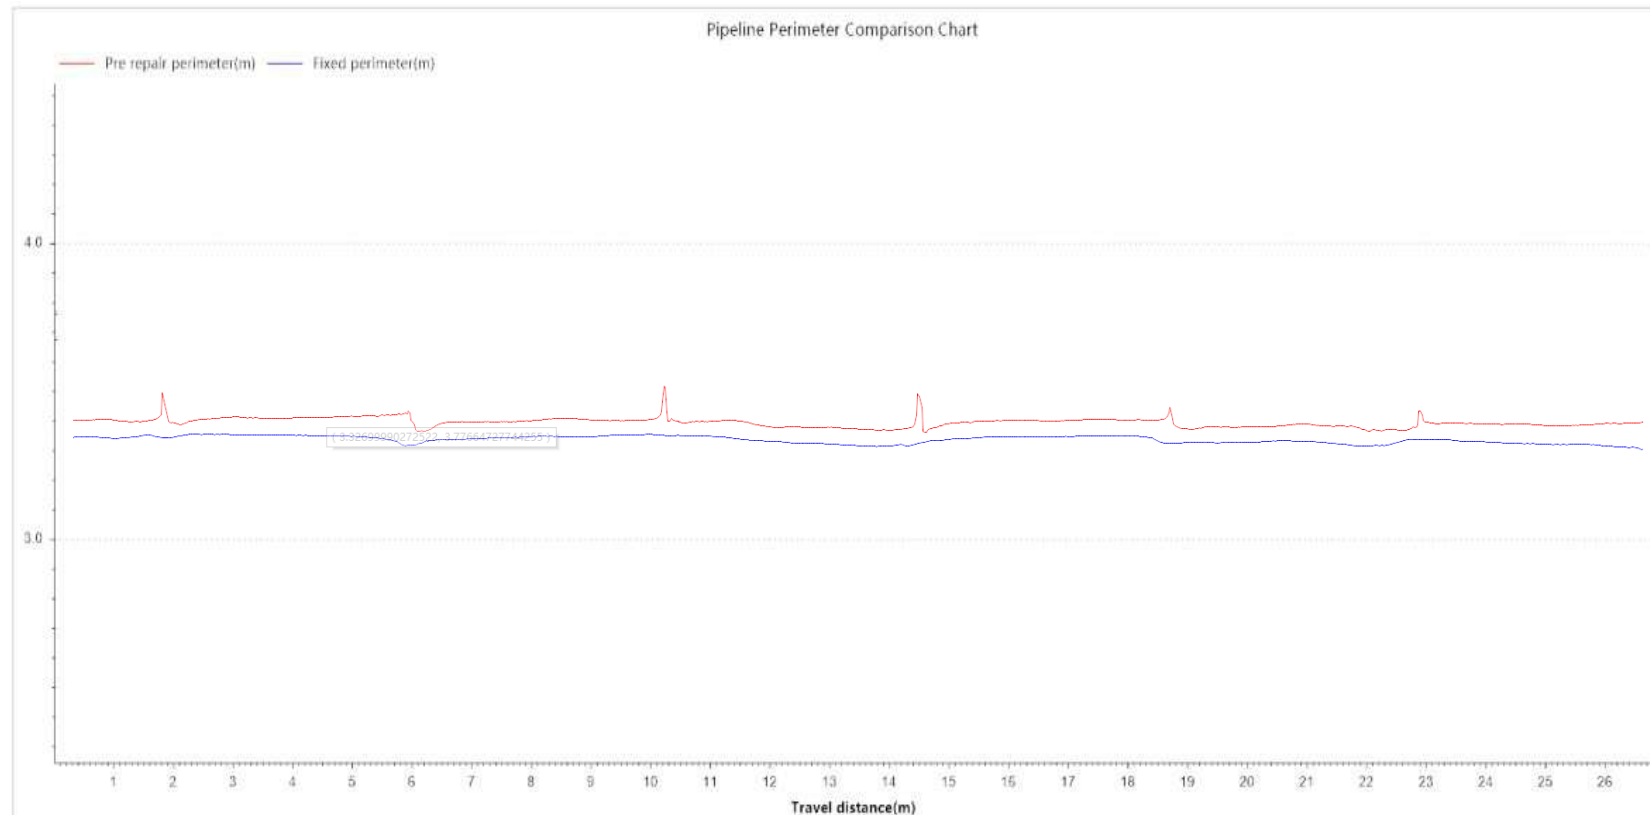
➤ Chart Analysis

Comparative analysis is performed from multiple aspects, including the **pipeline contour circumference diagram** before and after repair, pipeline wall thickness change diagram, pipeline contour expansion comparison diagram, etc.

The value interval can be set arbitrarily.

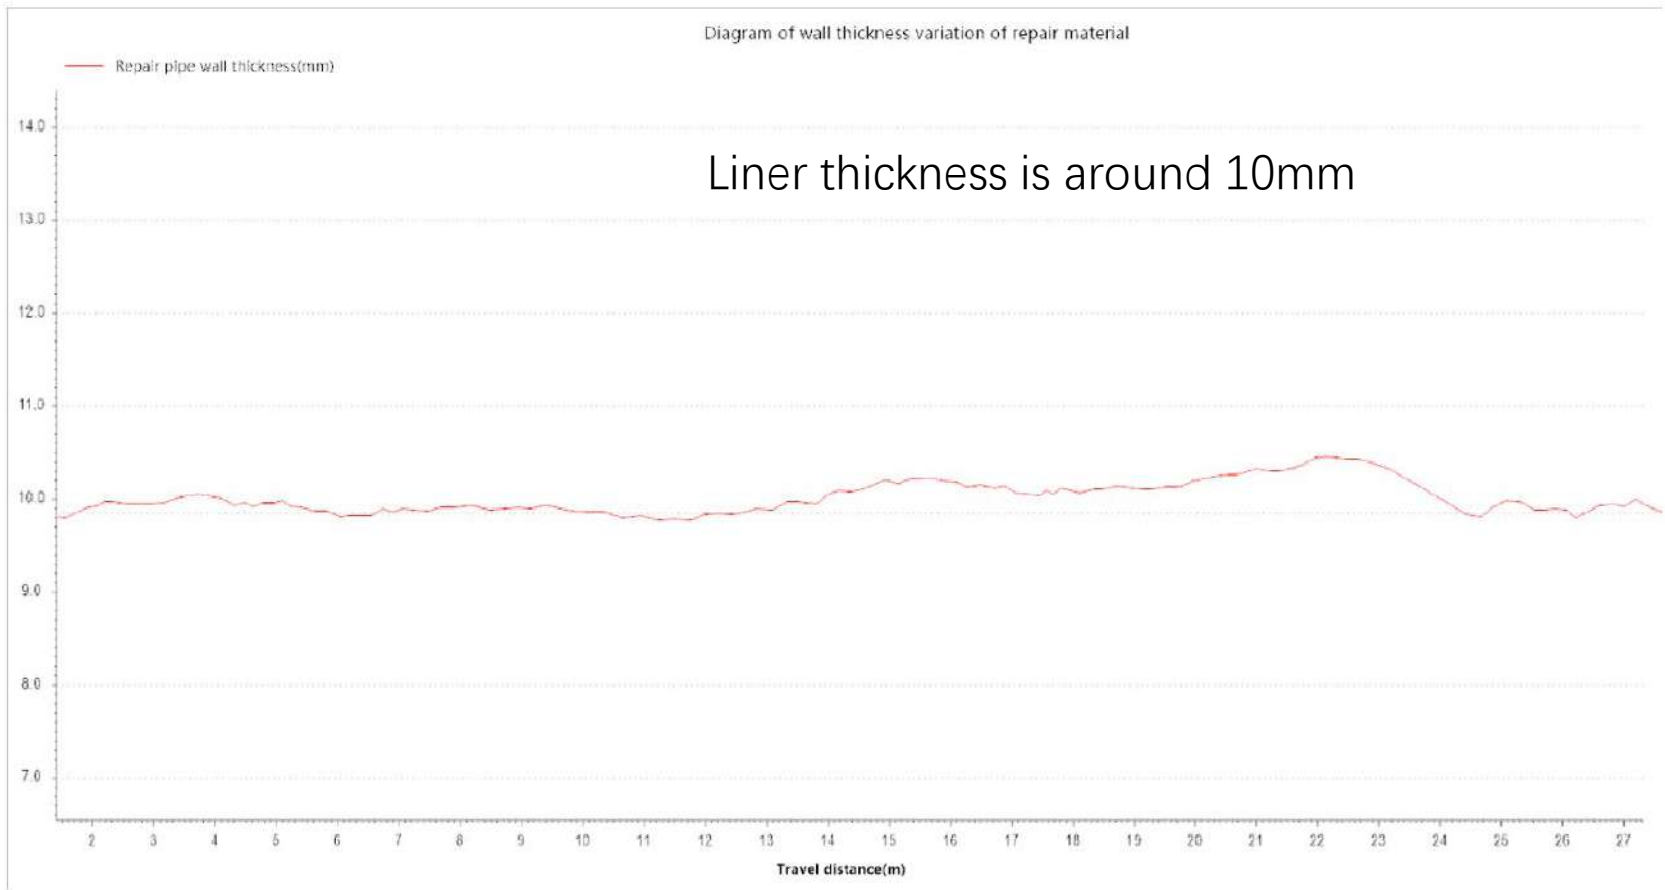
➤ **Chart Analysis**

Comparative analysis is performed from multiple aspects, including the pipeline contour circumference diagram before and after repair, pipeline wall thickness change diagram, pipeline contour expansion comparison diagram, etc. The value interval can be set arbitrarily.

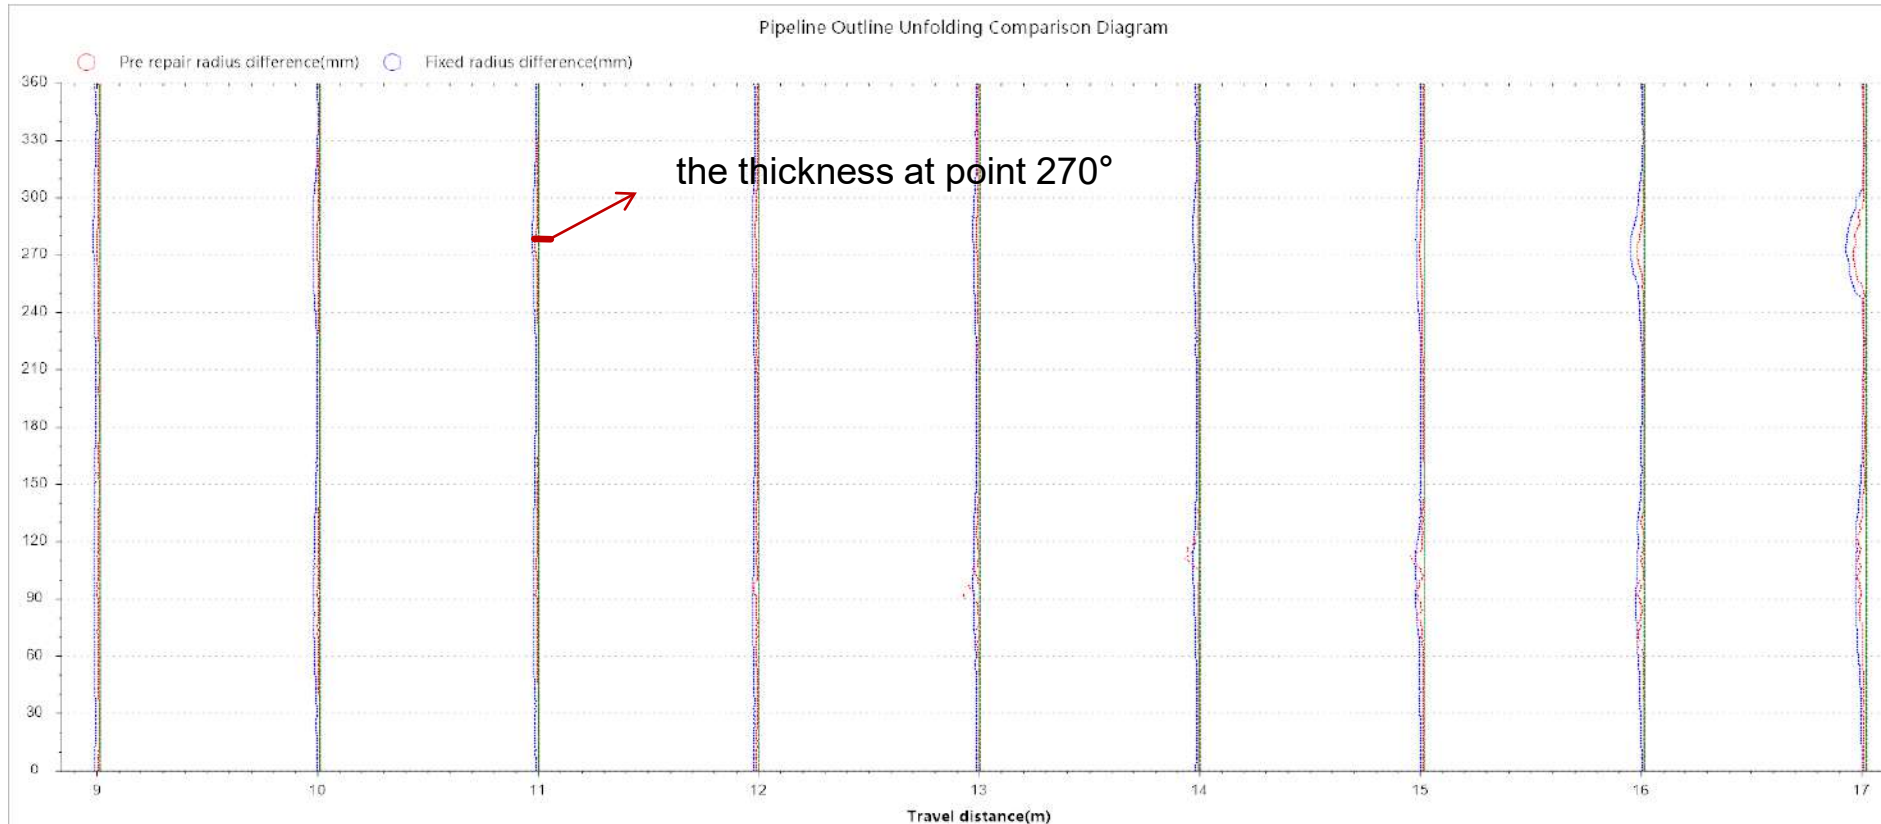
➤ Chart Analysis

Comparative analysis is performed from multiple aspects, including the pipeline contour circumference diagram before and after repair, **pipeline wall thickness change diagram**, pipeline contour expansion comparison diagram, etc. The value interval can be set arbitrarily.
