TRENCHLESS ASIA 2026

PIPELINE HIGH ACCURACY DETECTION TECHNOLOGY - PANORAMIC QUANTITATIVE ROBOT

ELLA XIAO

WUHAN EASY-SIGHT

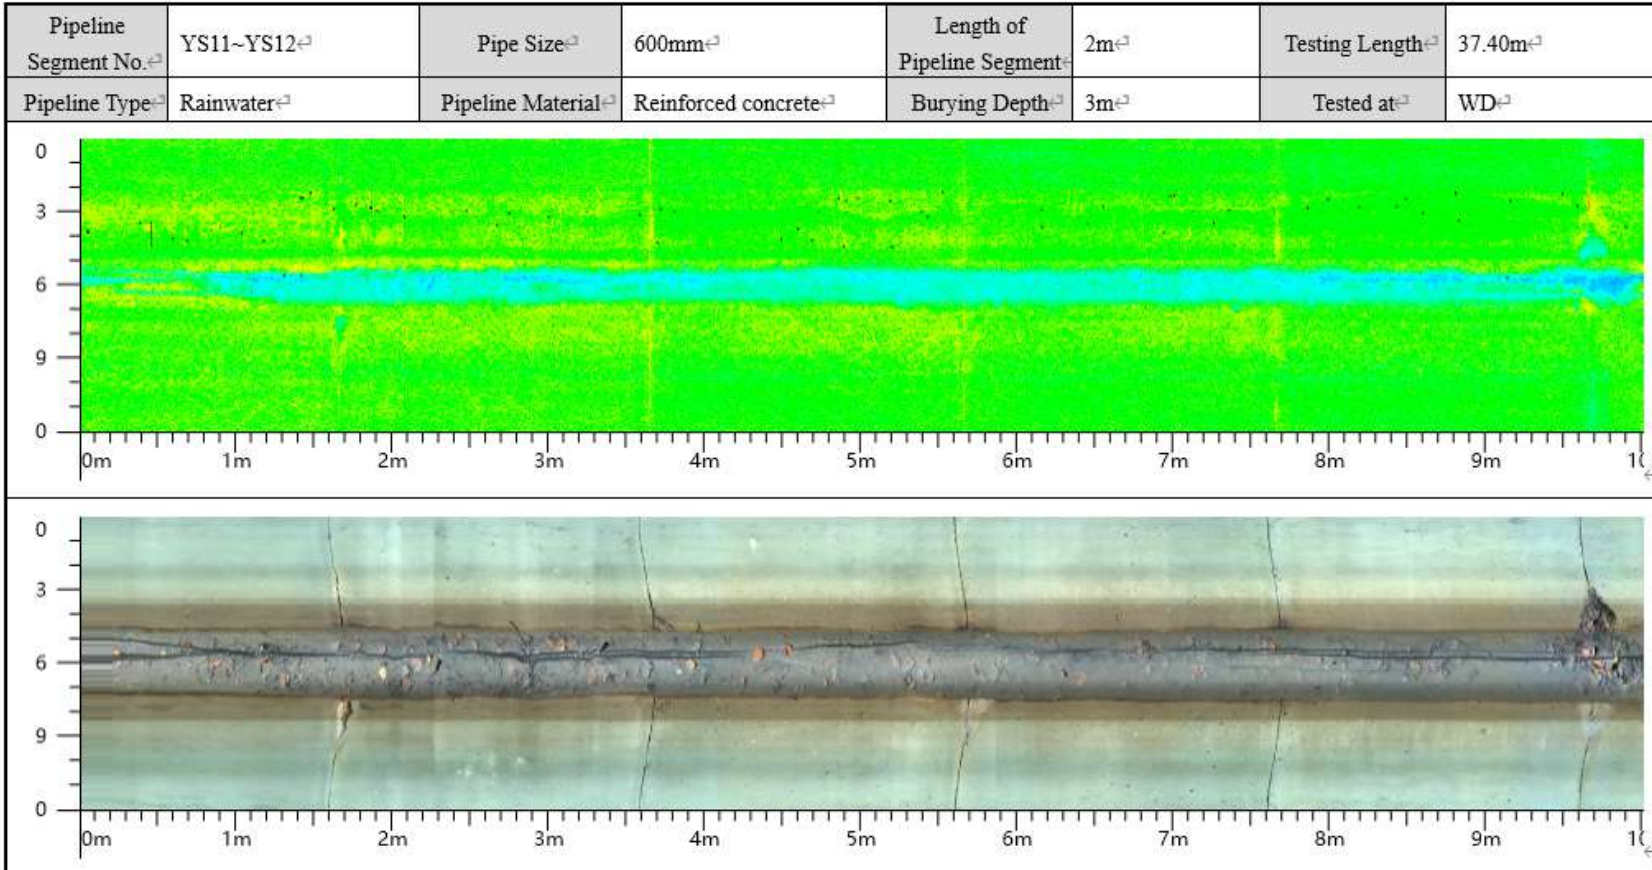
2.4 Pipeline Expanded View

Pipeline expansion diagram, intuitively showing the internal situation of the pipeline, blue indicates slight sediment

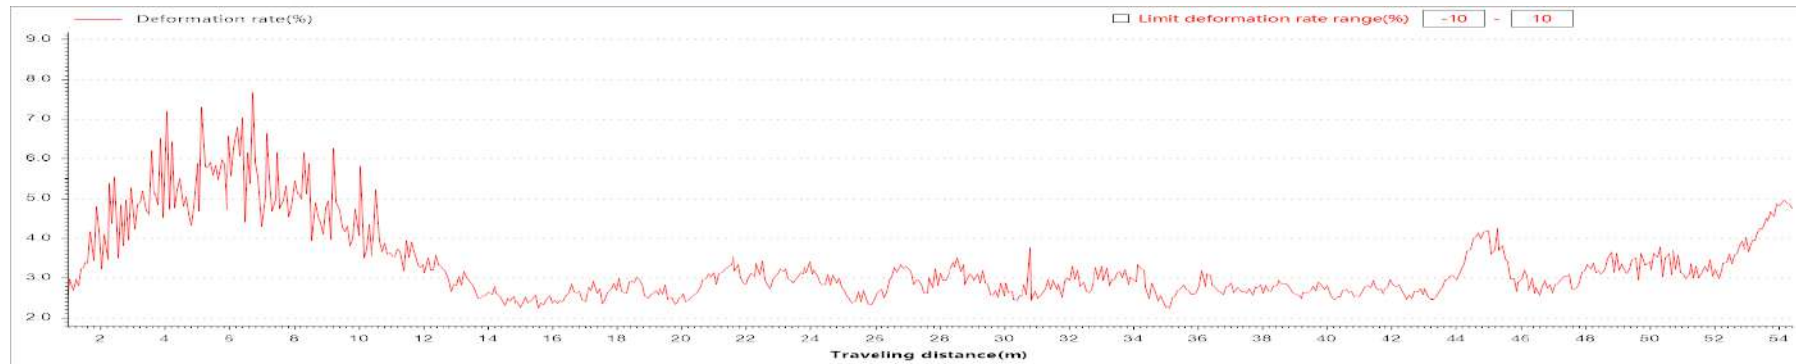
Pipeline deformation rate distribution diagram

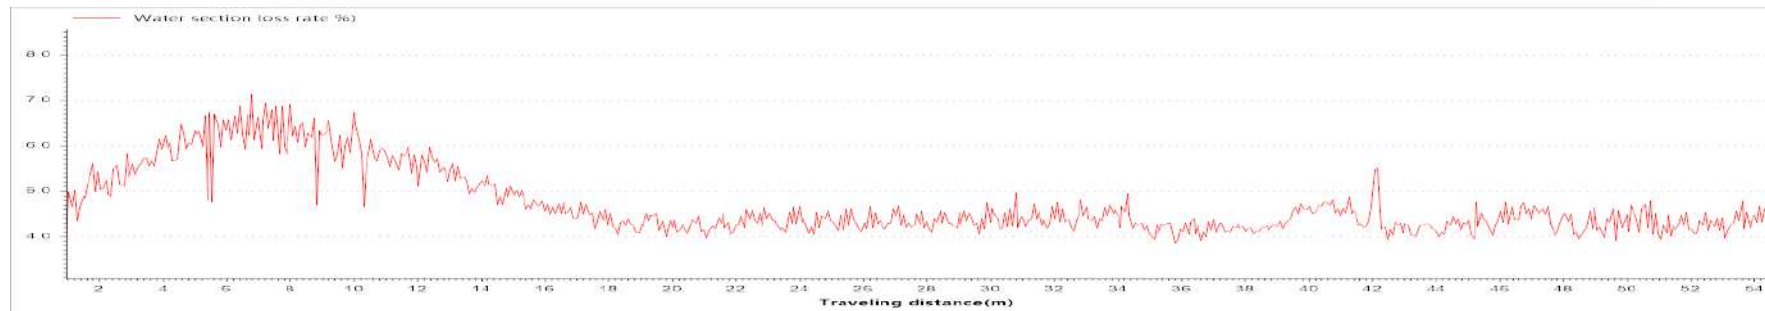
Drainage pipe water section loss rate diagram

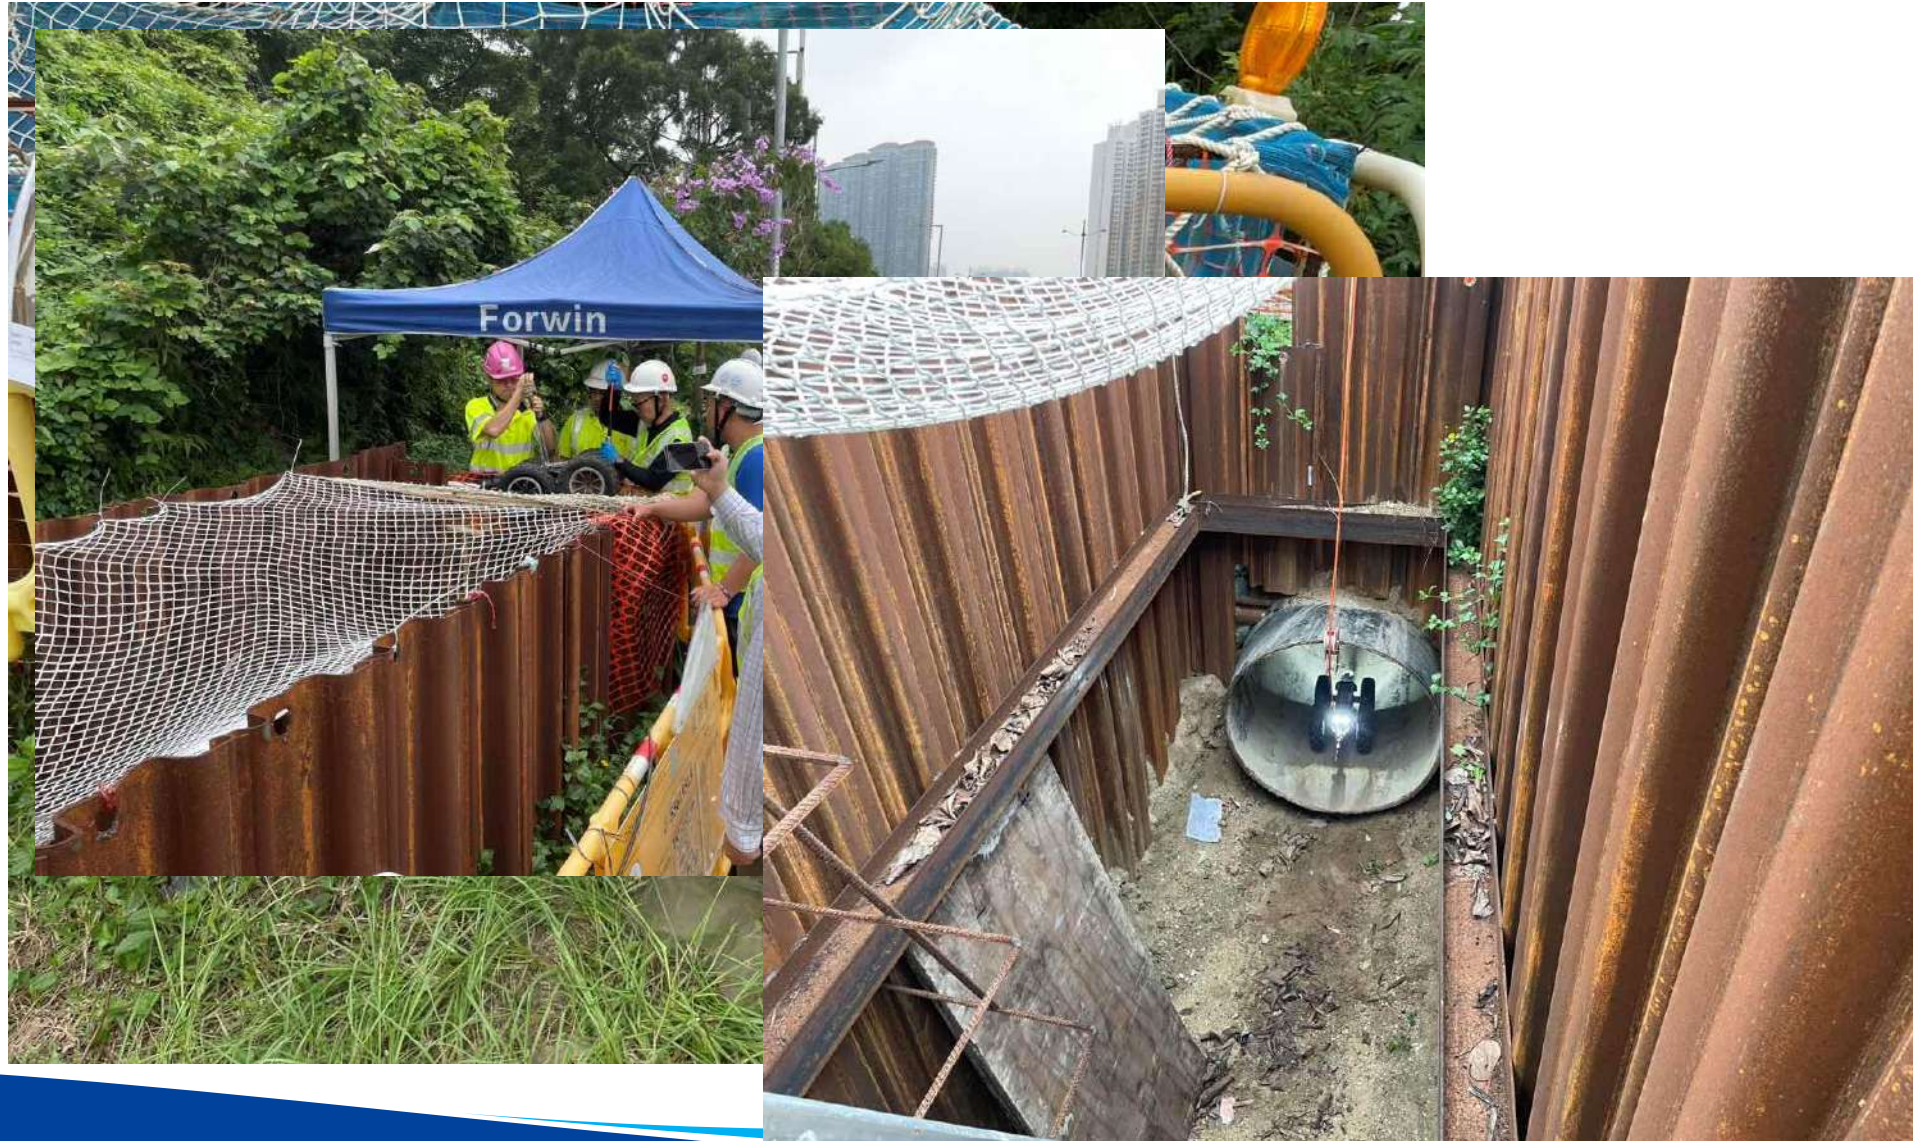
The Drainage Services Department of Hong Kong needs to repair a pressurized sewage pipe with a length of about 6KM and a pipe diameter of DN1200. Customized liner is difficult!!

The screenshot displays the PIPEPROF software interface for a pipe inspection analysis. The main window is titled '中仪股份 EASY-SIGHT PIPEPROF 管道量化分析系统'. The interface is divided into several sections:

- Main View (管道断面轮廓图):** A circular cross-section diagram of the pipe. It shows a red outline representing the actual pipe profile and a blue circle representing the nominal diameter. Key data points include:

- 变形率: -6.8%
 - 距离: 3.546m
 - 直径: 1179mm
 - 56/820 (red text)
 - Dimensions: 830mm, 553mm, 276mm.
 - 过水断面面积: 10932.5cm²
 - 过水断面损失率: 3.3%
 - 沉积宽: 429mm
 - 沉积高: 40mm

- Right Panel (视频图像):** A circular video image showing the interior of the pipe. It includes a scale bar and a compass. Metadata at the bottom reads: '距离: 3.52 m 速度: 0.12 m/s 2024-06-06 23:08:30 倍率: 1'.

- Bottom Panel (色谱图):** A longitudinal color spectrum graph showing the distribution of defects along the pipe length. The x-axis represents distance from 0 to 19 meters, and the y-axis represents depth from 0 to 9 meters. A color scale on the right indicates defect severity levels, ranging from '>25%' (red) to '<-10%' (blue).

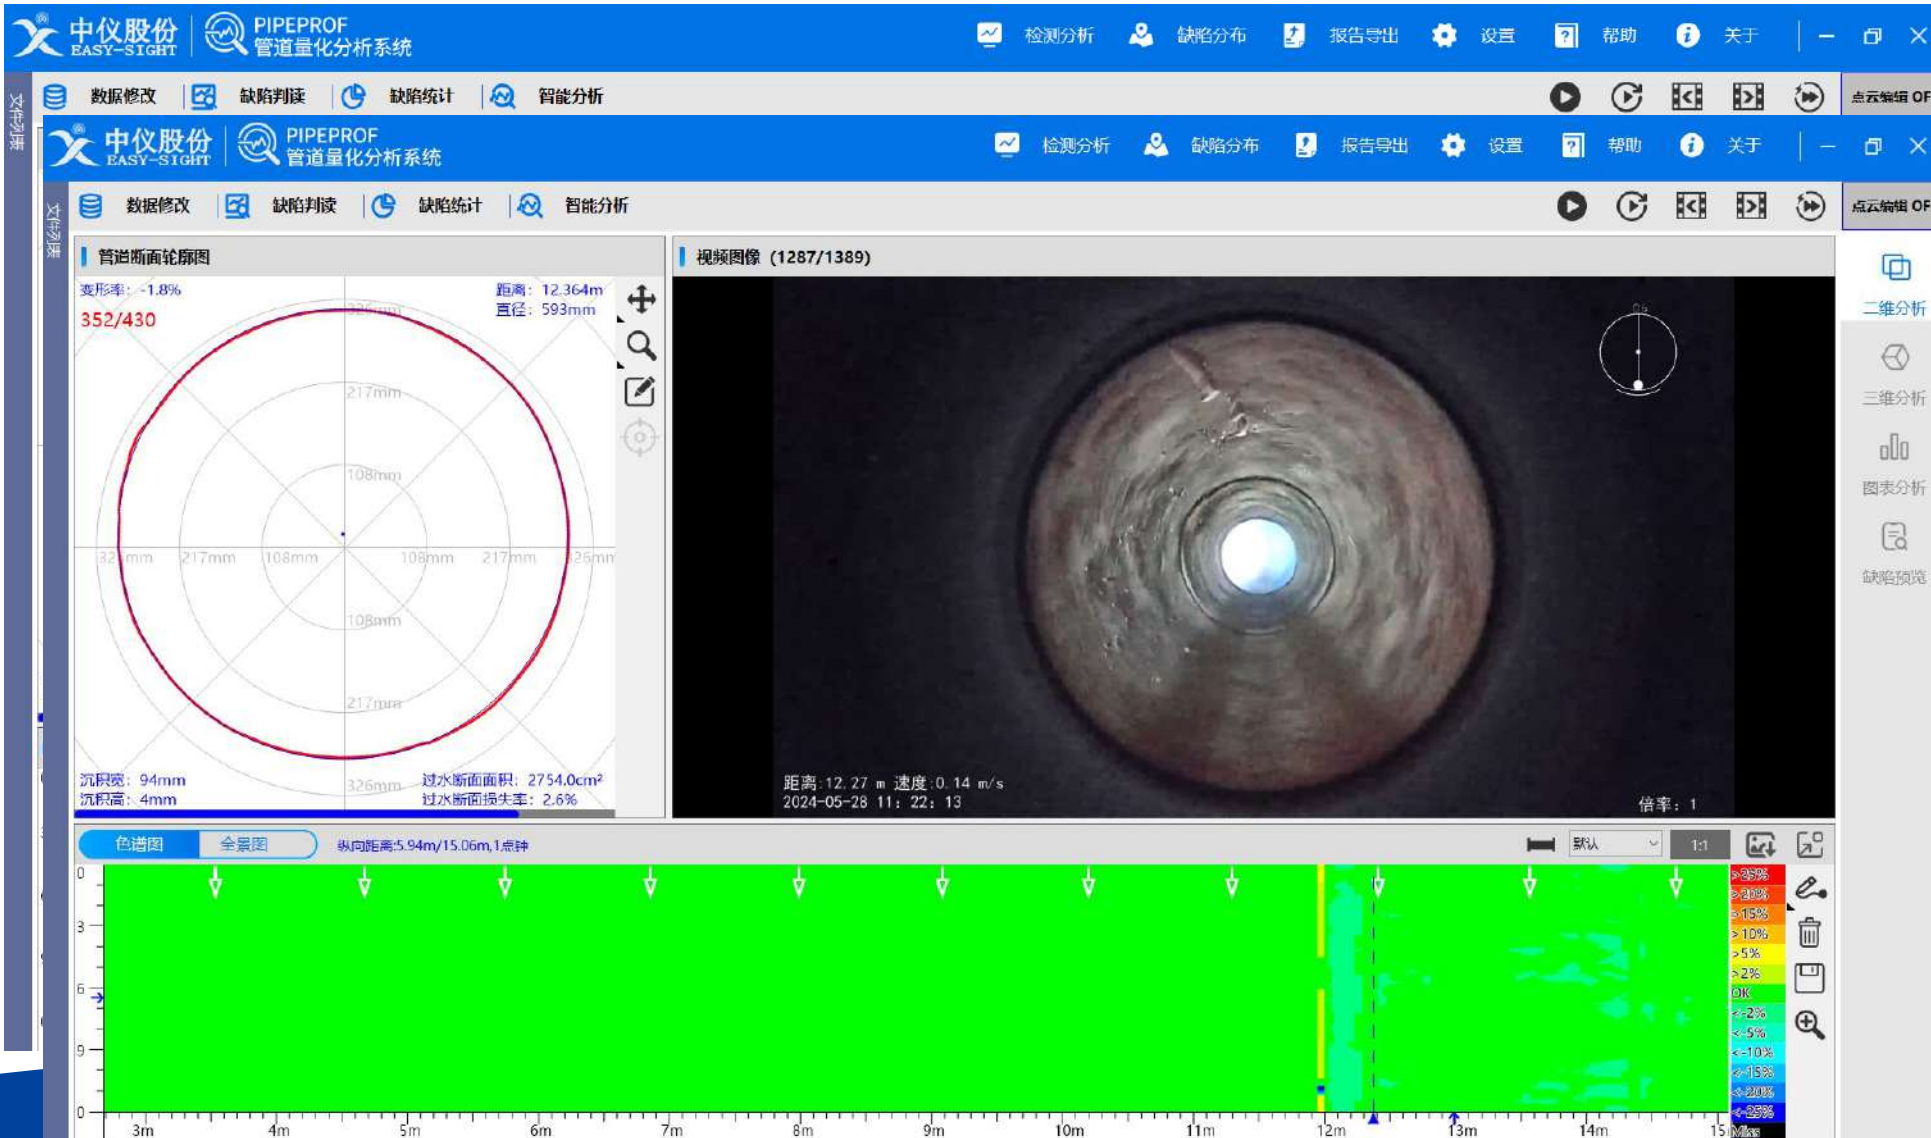
Xi'an

Lay a DN600 water supply pipeline, measure the change in the inner diameter of the pipeline, deformation rate, and other cleaning measures after laying. At 12m is the valve connection pipe, where you can see obvious scratches on the connection pipe and some distortion..

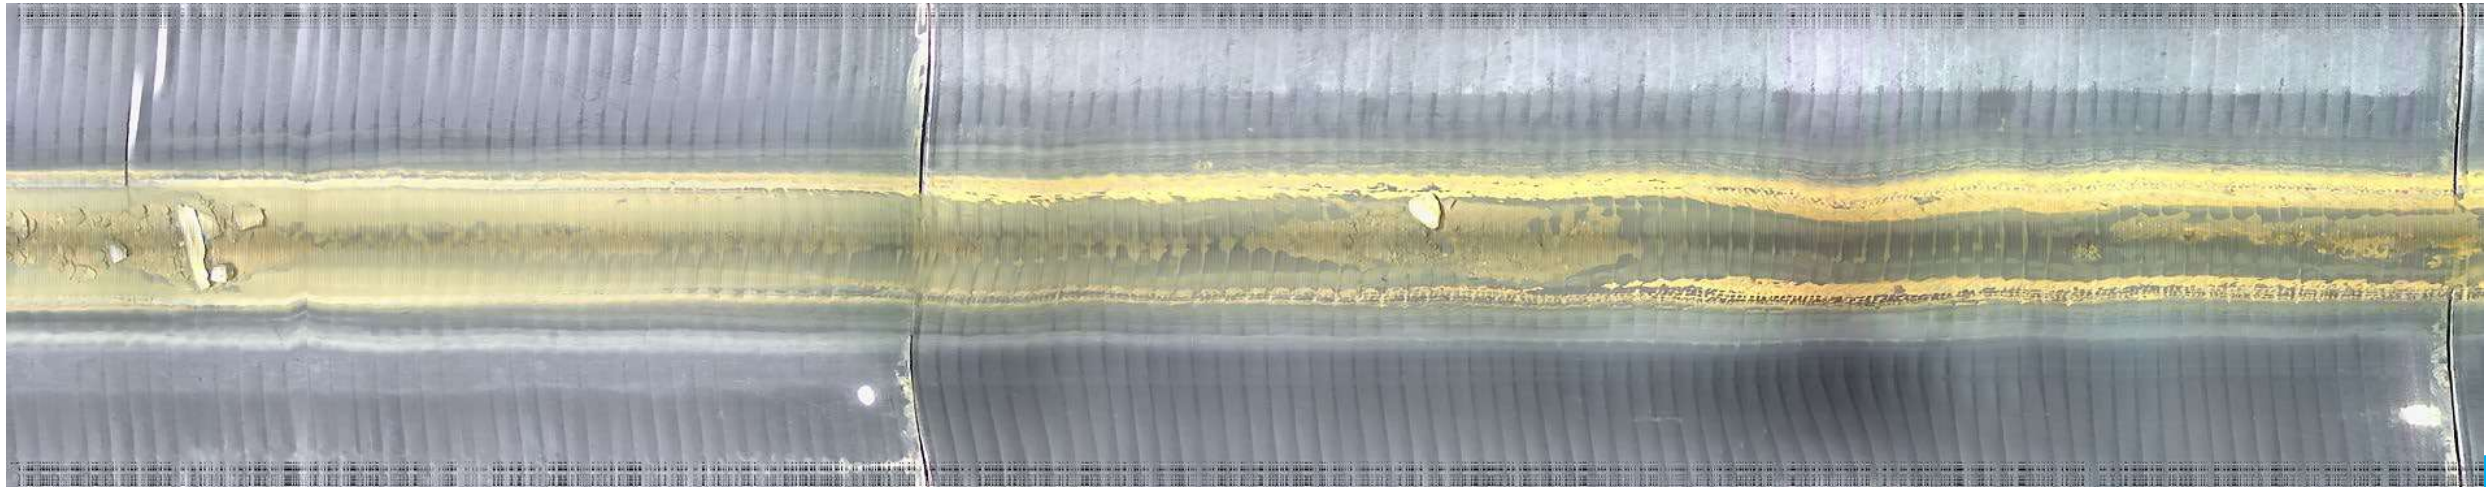
Wuhan

Application cases

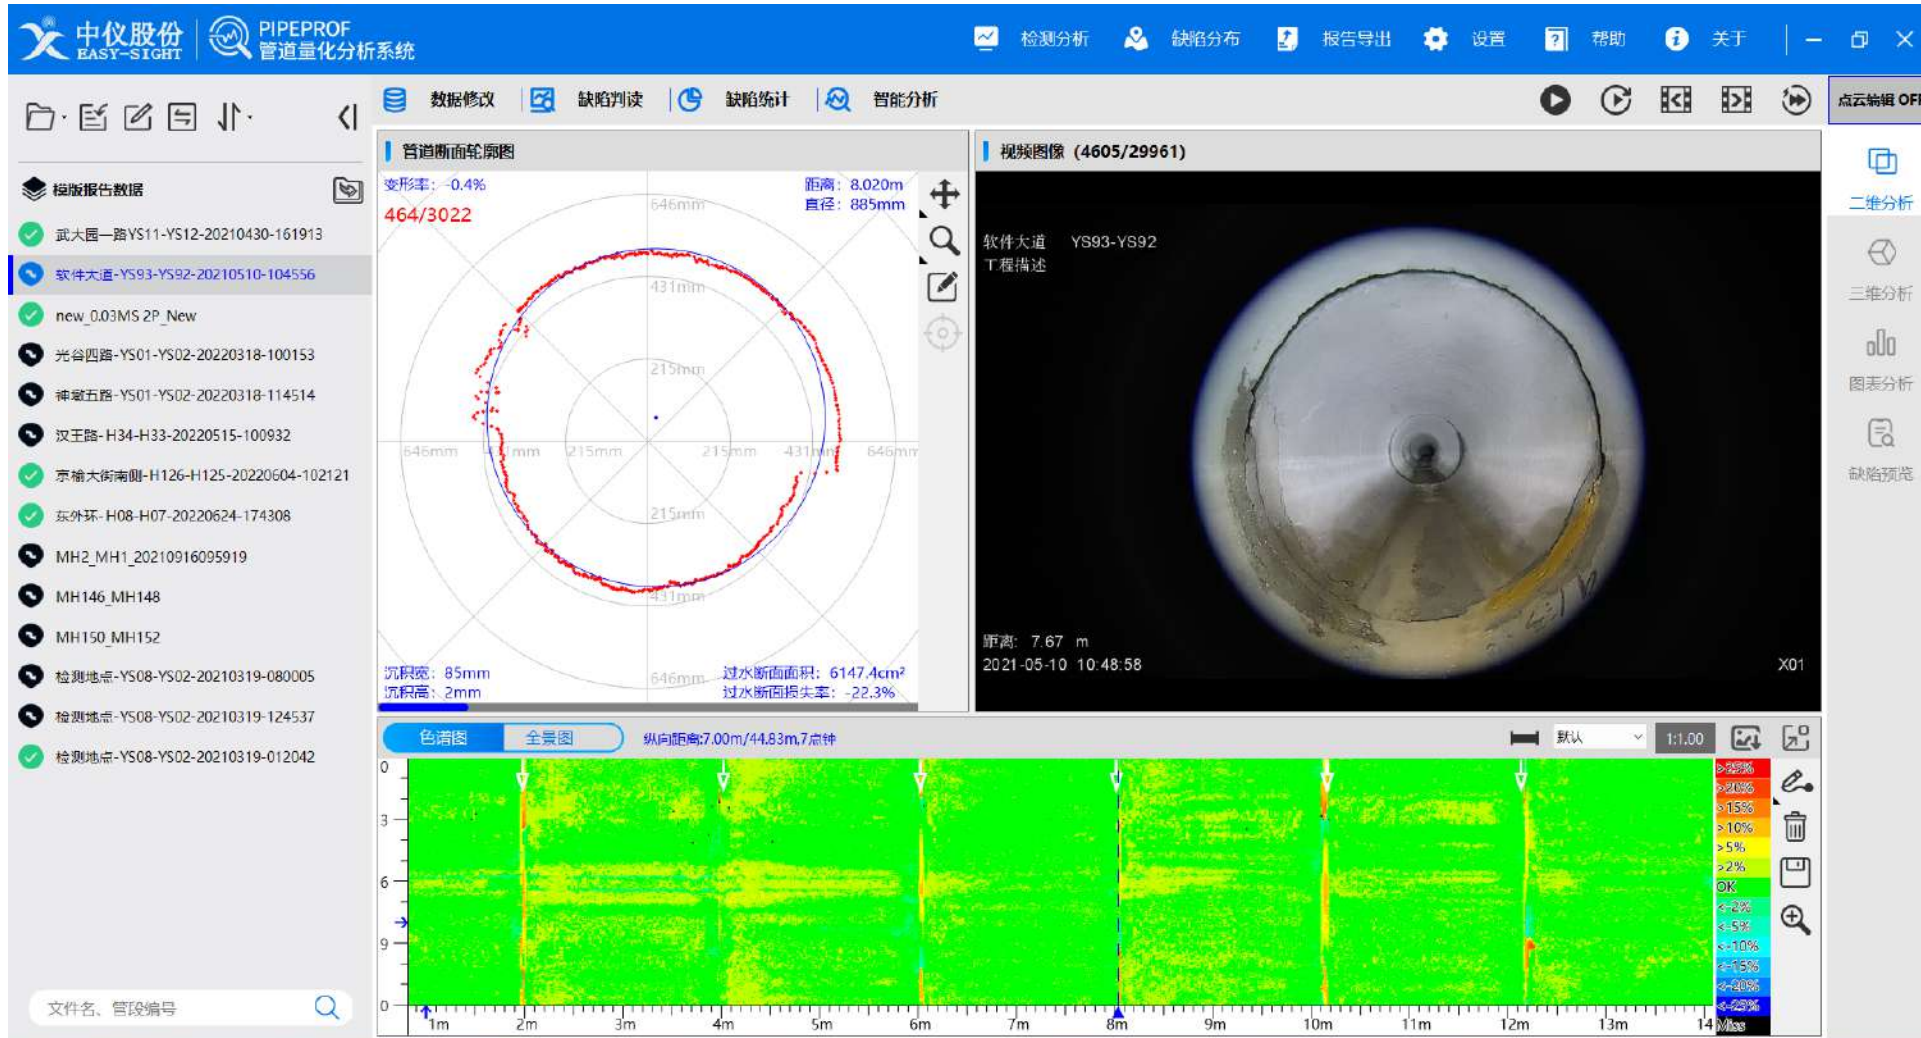
Inspection of DN800 pipeline, length 45 meters. From the chromatogram, it can be seen that the interior of the pipeline is generally good, but the interface has more serious problems, such as leakage at 8 meters.

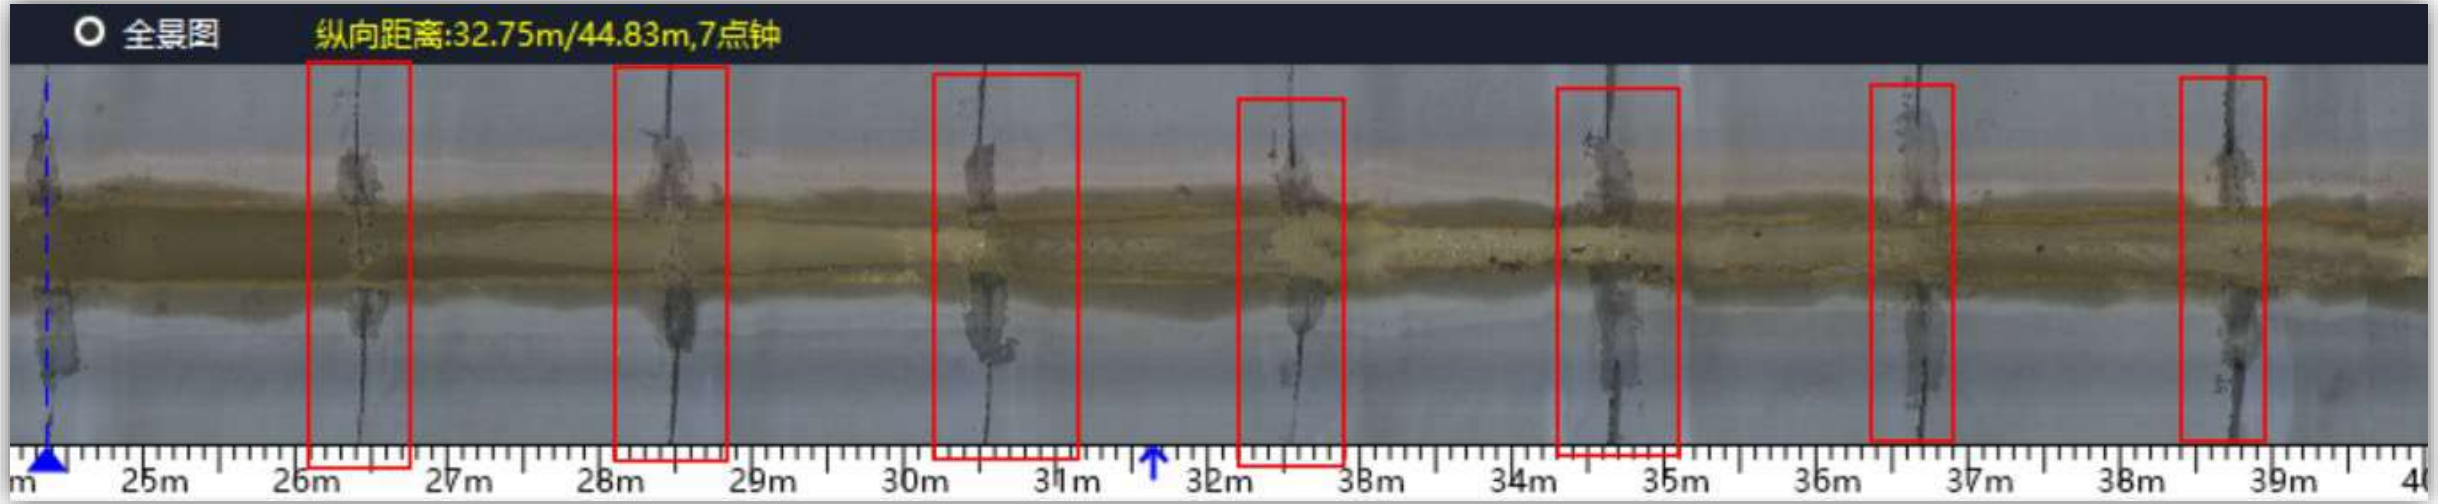
Through the panoramic view, we can clearly see that this problem exists at almost every joint of the pipeline, and all have been repaired. Each pipe section is in good health. This is something that cannot be directly observed using current CCTV.
