TRENCHLESS ASIA 2026

TRANSFORMING AGING PIPELINES WITH INNOVATION

MR. FAIZ AHMAD

Transforming Aging Pipelines with Innovation
Sekisui's Trenchless Spiral Pipe Method
Machine Wound Spiral Lining (MWSL)

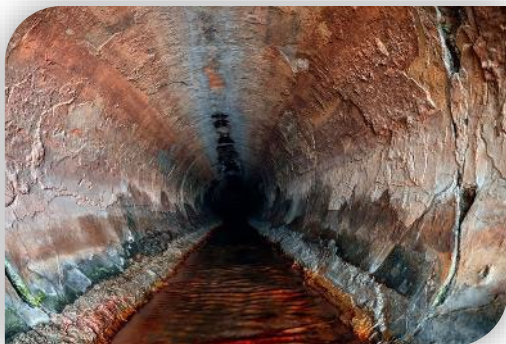
Aging pipes

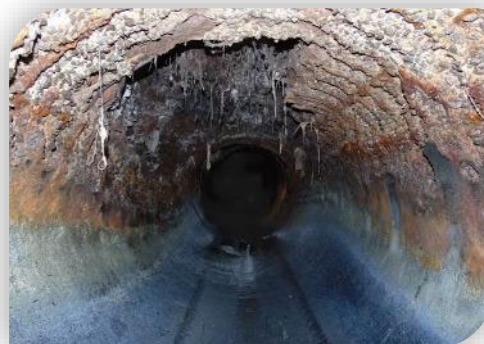
Corrosion due to gas attack

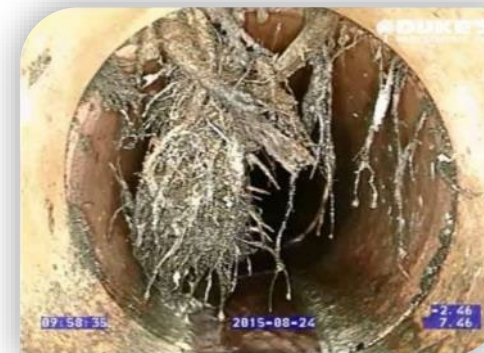
Tree root intrusion

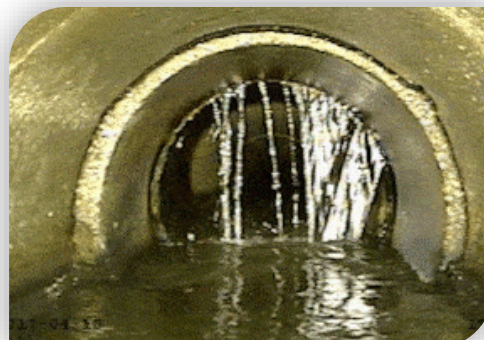
Infiltration

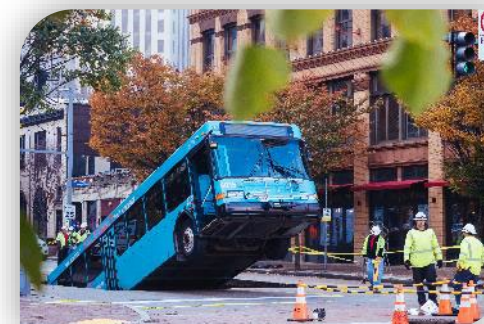
Road collapse

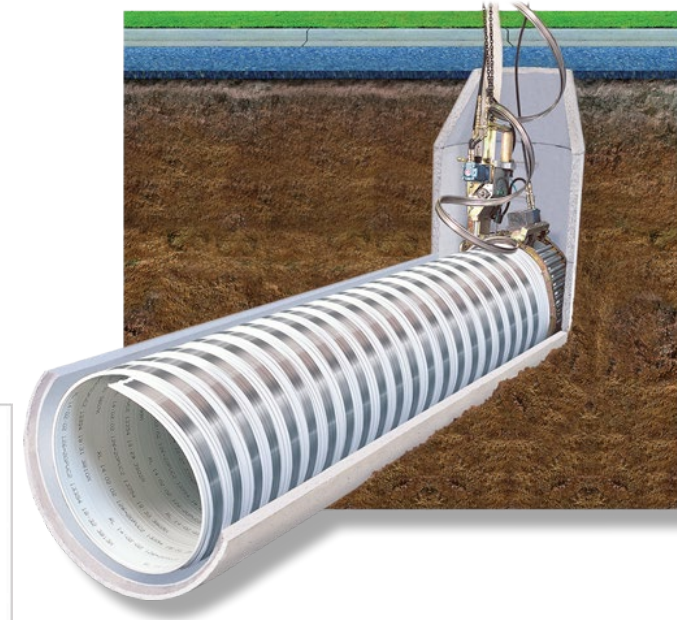
SPR-ST (MWSL) - Winding Systems

**Applicable diameter range
(600mm – 3500mm)**

- ① Profile Spool
- ② Roll Former & Steel Coil
- ③ Winding Machine
- ④ SPR™ ST Liner

- ✓ Diameter range: 600-3500mm and more
- ✓ First project in 1997
- ✓ Installed from existing access chamber
- ✓ Liner can be steel reinforced to increase stiffness if required
- ✓ Liner installed at a fixed diameter
- ✓ Liner diameter can be customized on site
- ✓ Annular space grouted

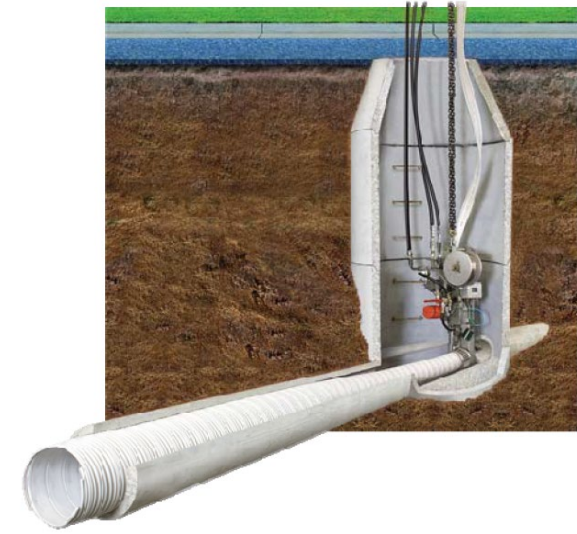
Applicable diameter range
(150mm – 1050mm)

- ① Profile Spool
- ② Winding Machine
- ③ Generator, Hydraulic Power Pack, Sealant Dispenser, etc.
- ④ SPR™ EX Liner

- ✓ Diameter range: 150-1050mm
- ✓ First project in 1990
- ✓ Over 700,000m installed
- ✓ Installed from existing access chamber
- ✓ Expanded in diameter during installation to form full bore structural liner

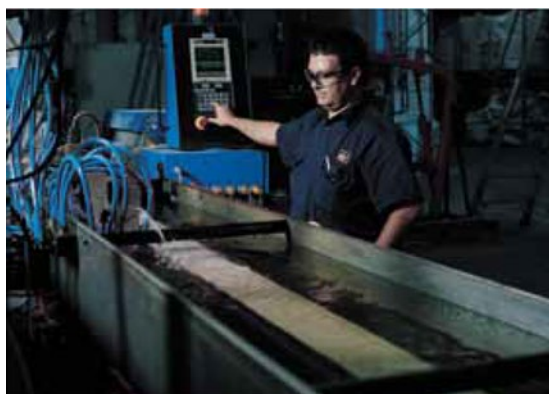
Profile extrusion

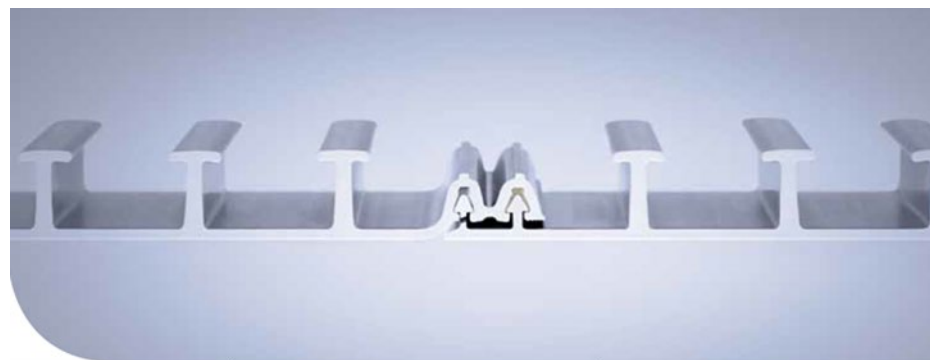
SPR-ST profile

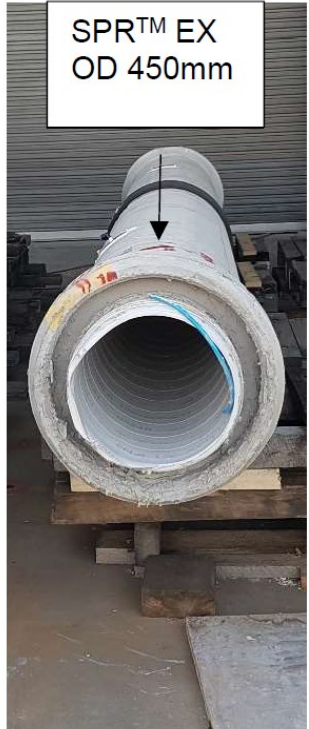
Long Term Water Tightness Test

Product	Profile type	Diameter (OD, mm)	Length of liner (mm)	Host material	Host pipe diameter (ID, mm)	Installation Date	Remarks
SPR™ EX	126-20EX	450	5510	Reinforced Concrete	450	16/05/2019	Close-Fit

Table 1 – Test sample details

Inspection of Sample Liner: 126-20EX

Date/ Time	Visual inspection of liner wall for infiltration	Visual inspection for external leak of end seal and fitting	Hydrostati c Pressure (kPa)	Hydrost atic Head (m)	Ambient temp (°C)	Rain gauge spike (200ml)	Comments
18/7/19 9:00am	None	No Leak	54.0	5.8	12	No	Start of test*
14/8/19 12:15pm	None	No Leak	55.9	5.7	13	Yes	Testing inspected
27/8/19 10:15am	None	No Leak	56.6	5.8	10	No	Testing inspected *
5/9/19 10:30am	None	No Leak	56.5	5.8	18	Yes	Testing inspected *
3/10/19 9.25am	None	No Leak	55.1	5.6	20	Yes	Testing inspected *
12/11/19 1:30pm	None	No Leak	55.2	5.5	27	No	Testing inspected *
21/11/19 2:50pm	None	No Leak	53.2	5.5	22	No	Testing inspected
24/1/20 1:00pm	N/A	N/A	N/A	N/A	N/A	N/A	Test was completed

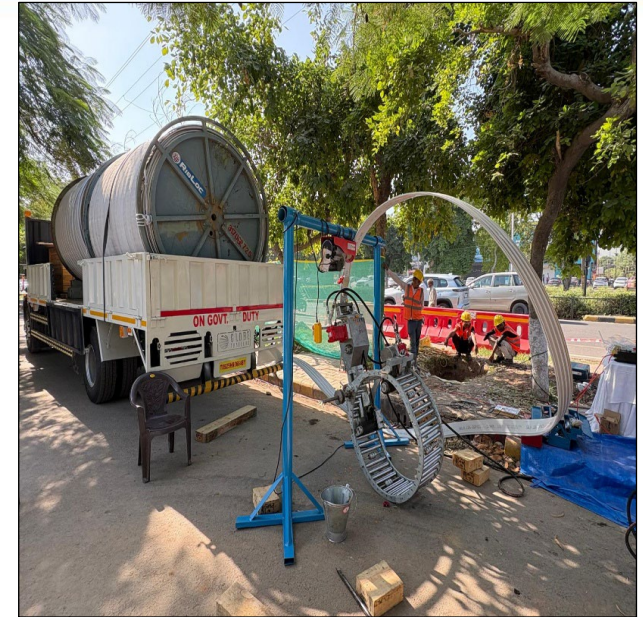
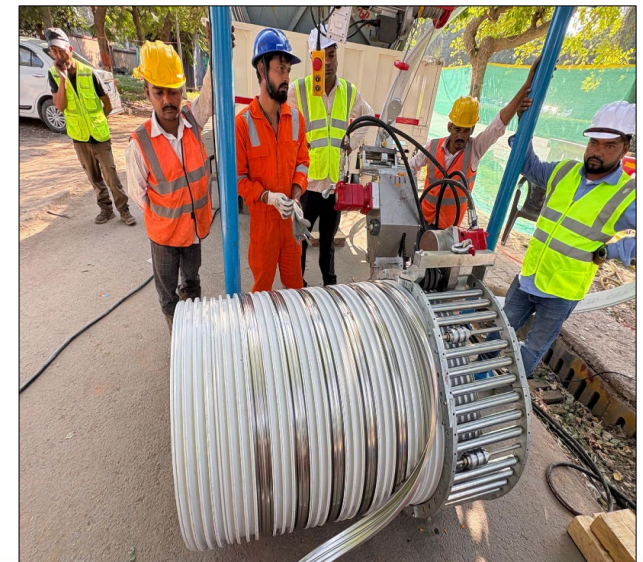
Case Study - India

- **Client:** Panchkula Metropolitan Development Authority
- **Location:** Geeta Chowk to Town Park, Panchkula
- **Line Details:** DN 900 mm stormwater drain | 700 meters
- **Technology:** Sekisui SPR-ST (Spiral Wound Lining)

- **Structural Risk:** Routine CCTV inspection revealed an aging pipeline with severe structural degradation, posing a proactive public safety risk.
- **Urban Constraints:** Required an efficient rehabilitation solution that could adapt to live flow conditions without extensive open excavation.
- **Market Momentum:** This project establishes SPR-ST as a preferred trenchless technology for stormwater networks across Haryana state.

- **Trenchless Execution:** Structural PVC liner spirally wound directly into the host pipe via a compact winding cage system, fully restoring structural integrity.
- **Live Flow Adaptability:** High-efficiency installation safely completed under live flow conditions with no structural defects or misalignments.
- **Minimal Disturbance:** Low noise generation and an ultra-small asset footprint allowed for continuous day and night operations without disrupting local traffic.

- **Flawless Delivery:** 100% of the 700-meter section successfully lined; post-work CCTV surveys confirmed a perfectly tight, uniform fit.
- **High Client Satisfaction:** Authority representatives observed the process firsthand and commended the rapid installation and minimal surface footprint.
- **Sustainable Infrastructure:** Proven capability establishes a highly scalable model for sustainable infrastructure management across Indian municipal bodies.

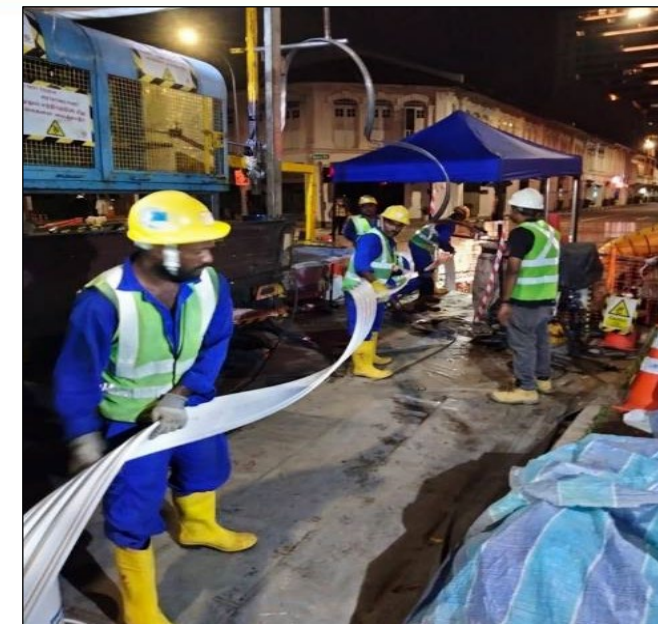
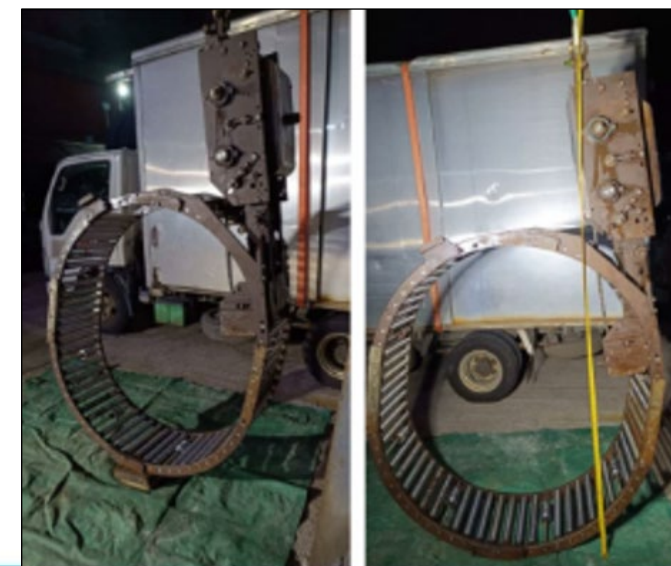
- **Client:** Public Utilities Board (PUB)
- **Location:** Owen Road, Singapore
- **Application:** Sewer Rehabilitation by Trenchless Technology (MWSL)
- **Year:** 2024
- **Product:** SPR-ST
- **Length:** 119.28 meters
- **Diameter:** DN 1295 mm

- During a routine CCTV survey inspection conducted by the relevant authority, a 1,295 mm diameter sewer pipe located along Owen Road, Singapore, was found to be in a severely deteriorated condition. The inspection revealed a broken crown and multiple cavity formations above the pipe at various points along the 119.28-metre sewer line. Originally constructed in 1941, this aging sewer required urgent rehabilitation to prevent further structural degradation and eliminate any proactive risk to public safety.

- In Singapore, sewer lines with diameters exceeding 600 mm are categorized as big-diameter sewers, making the Spiral Wound Lining SPR-ST method the standard choice for structural rehabilitation. The process involves winding interlocking PVC strips and steel reinforcement in a spiral pattern using a specialized winding cage.

- Following the completion of the trenchless rehabilitation works, a detailed post-work CCTV survey was conducted as a final quality assurance inspection. The internal camera verification confirmed that the structural integrity of the rehabilitated sewer met all mandated engineering standards, showing a smooth interior with absolutely no remaining defects, misalignments, or blockages.
